Time Dependent Early Breakdown of AlGaIn/GaN Epi Stacks and Shift in SOA Boundary of HEMTs Under Fast Cyclic Transient Stress

Bhawani Shankar¹, Ankit Soni¹, Sayak Dutta Gupta¹, Swati Shikha¹, Sandeep Singh¹,
Srinivasan Raghavan² and Mayank Shrivastava¹

¹Department of Electronic Systems Engineering and ²Center for Nanoscience and Engineering,
Indian Institute of Science, Bangalore, India, email: mayank@iisc.ac.in

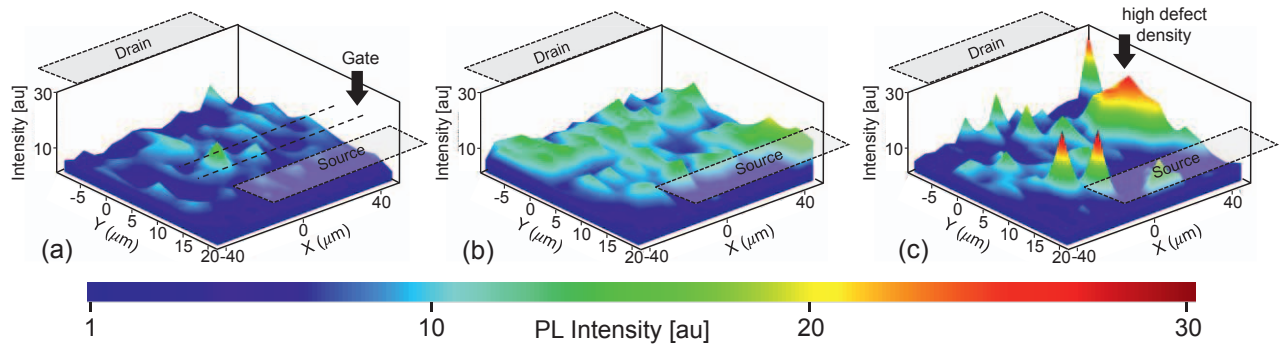
Fig. 9. PL intensity distribution for defect band (425-525nm) captured between source-drain region of the HEMT device (a) before stress, (b) after stressing with 5000 pulses and (c) at the verge of failure. Figure reveals that the density of mid-bandgap defects, increases with number of pulses (of 200V) with peak concentration close to drain contact edge.

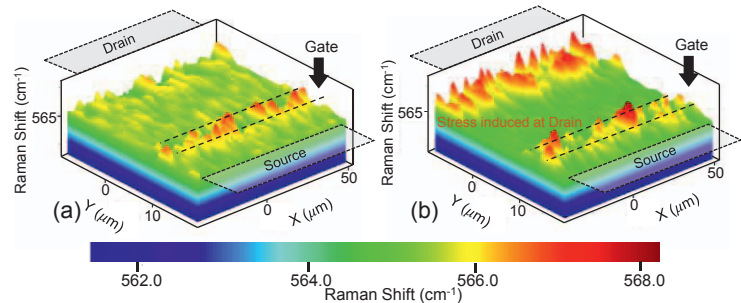
Fig. 11. (a) Raman map captured between source - drain region of pristine device, i.e. before applying stress. Figure reveals residual compressive stress in recessed region under gate. (b) Raman map of the device after application of 5000 stress pulses (@180V) between drain and substrate. Stress accumulation can be noticed near the drain contact edge, beside gate finger.

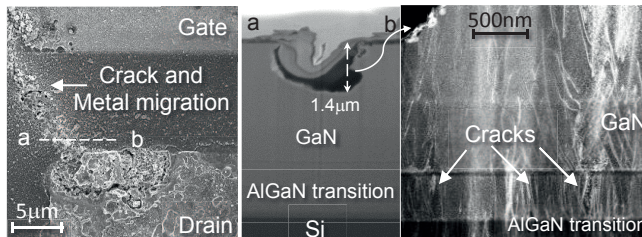
(a) Post Failure SEM (b) x-sect. SEM (c) HR-TEM Image

Time to Vertical Breakdown under Pulse Stress: Time to fail (TTF) extracted using fast transient cyclic pulse stress shows exponential dependence on applied stress voltage (Fig. 5) however the TTF was found to be much smaller compared to the same under DC stress case. For instance, 600V GaN Epi-stack qualified for 10-year lifetime under DC stress, failed after ~100 pulses, each being 500ns wide. Interestingly, TTF was found to improve when pulse rise time was increased, which indicates transient time dependent failure to be related to rate of change in electrical stress. Unlike under DC stress case (Fig. 6b), under cyclic pulse stress the vertical leakage with stress time remain unchanged till the verge of failure (Fig. 6a). Rapid and more sever changes in device characteristics are observed under pulse stress compared to that under dc condition (Fig. 7). Drain to substrate vertical leakage hysteresis was found to increase with stress time under pulse stress (Fig. 8), which points to charge trapping in different layers present between drain and substrate. PL mapping of drain-source region (Fig. 9) reveals increased defect generation introducing deep level traps within energy range of $E_C - 0.48$ eV and $E_C - 1.14$ eV. Highest PL intensity is observed near the drain contact (Fig. 9c). CL spectra (Fig. 10) taken at same location verifies increase in Blue (BL) and Yellow luminescence (YL) intensities with stress and penetration depth of ~1.2 μm from top surface. Hence, defects in GaN buffer are located close to 1.2 μm below surface in the drain contact vicinity. Raman map confirms mechanical stress builds up at the drain contact edge after the device is stressed for 5000 cycles under pulse condition (Fig. 11). Since AlGaIn is transparent to used visible (532 nm) laser, the stress signature received is from GaN buffer. This correlates well with penetration depth calculated from CL. Post failure cross-sectional SEM shows a catastrophic damage in GaN buffer, in vicinity of drain contact (Fig. 12). HR-TEM of defected region reveals fine cracks near GaN buffer and AlGaIn transition interface (Fig. 12). However, under DC stress, damage is localized to device surface and no failure signature is observed in the bulk.

Fig. 12. (a) Top view SEM image depicting HEMT device failed under 600V pulse stress condition. Failure occurred with massive crack in the gate-drain region. (b) Cross-sectional SEM taken along line a-b reveals that the damage reached 1.4 micron deep into GaN buffer. (c) HR-TEM image of the region below damage area depicts cracking at the interface of GaN buffer/AlGaIn-transition region.

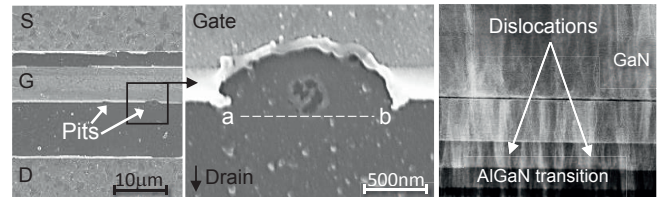
(a) Post Failure SEM (b) HR-TEM Image

Fig. 13. (a) Top view SEM images of HEMT device failed after 600V of DC stress depicts shallow damage confined to top surface. (b) Cross-sectional TEM along a-b line shows no damage in bulk along dashed line 'a-b', reveals the failure occurred in device's active region close to AlGaIn/GaN interface at the top. No signature of bulk failure found. Similar localized failures observed in other dc stressed devices near top surface.

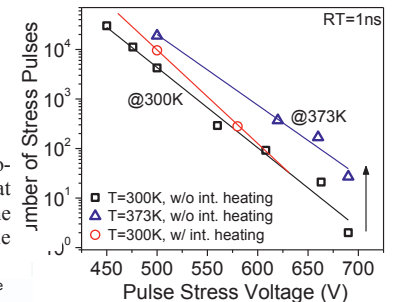
Validation of Proposed Failure Model: Stress accumulation and defect generation in GaN epi layers under pulse condition occurs due to electrical cyclic loading via compressive piezoelectric stress. Heating in device introduces thermoelastic tensile stress [16] which partially relaxes the field induced piezoelectric stress, as confirmed using Raman mapping (Fig. 16). This resulted in TTF improvement when stress applied at higher temperature or heat treatment was given in between cyclic stress (Fig. 17).

Fig. 16: (a) Post stress Raman map device stressed using 5000 pulses depicts stress accumulation around drain contact. (b) Relaxation in device stress, confirmed from Raman map captured, after the device was heated at 100°C for 10 mins post pulse stress
