# Trap Assisted Avalanche Instability and Safe Operating Area Concerns in AlGaIn/GaN HEMTs

**Abstract**— This work reports the very first systematic study on the physics of avalanche instability and SOA concerns in AlGaIn/GaN HEMT using sub- $\mu$ s pulse characterization, post stress degradation analysis, well calibrated TCAD simulations and failure analysis by SEM and TEM. Impact of electrical, as well as thermal effects on SOA boundary and avalanche instability are investigated. Trap assisted cumulative nature of degradation is studied in detail, which was discovered to be the root cause for avalanche instability in AlGaIn/GaN HEMTs. Post failure SEM/TEM analysis reveal distinct failure modes in presence and absence of carrier trapping.

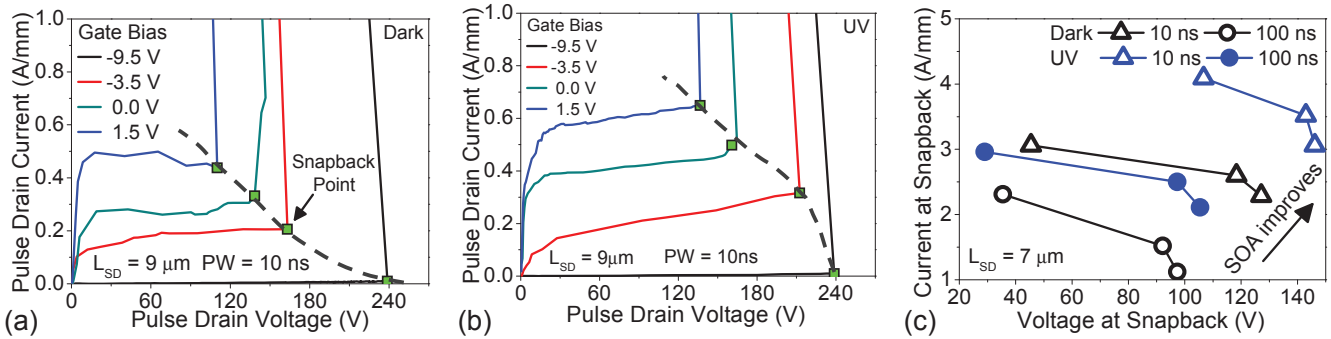
Pulse I-V characteristics extracted for HEMTs with passivation, under dark and UV light condition, depict an improvement in SOA boundary with UV exposure (Fig. 2a-b). Similar observations can be made from Fig. 2c for devices without passivation, which shows that SOA boundary improves for shorter pulse widths and in presence of UV exposure. Improved SOA boundary for shorter stress times

Fig.2: Pulse I-V characteristics of HEMT with surface passivation extracted (a) under dark condition and (b) with UV exposure. Carrier trapping in different regions degrade device causing early failure. UV exposure improves SOA by assisting in carrier de-trapping and suppresses degradation, which avoid premature device failure. Snapback point shown here marks the onset of device failure and SOA boundary. (c) SOA boundary of HEMT devices (without surface passivation) stressed using different pulse widths under dark and UV condition.

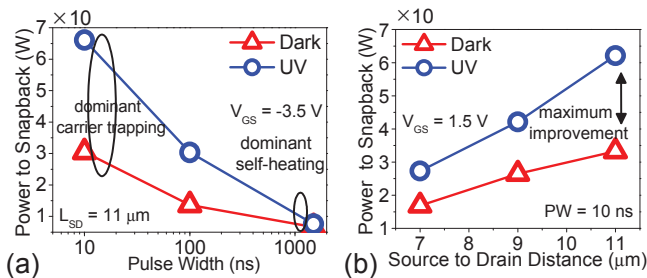
Fig. 3: (a) Power to snapback as a function of pulse width extracted under dark and UV condition. While exhibiting power law behavior presence of UV improves power to snapback at shorter pulses. (b) Power to snapback as a function of source – drain spacing. It increases linearly with  $L_{SD}$  and shifts upwards with UV exposure.

indicates presence of thermal effects, whereas the same in case of UV exposure signifies role of surface and/or buffer traps. On the verge of failure i.e. at snapback point, the power-to-snapback was observed to decrease with increase in pulse width, exhibiting a power law like behavior, under both dark and UV light conditions (Fig. 3a). Power-to-snapback for longer stress times remains same for both UV and dark condition; but differs by  $2\times$  at 10 ns. Furthermore, linear scaling of power-to-snapback with source-to-drain spacing ( $L_{SD}$ ) is also observed (Fig. 3b). After each stress pulse linear drain-to-source dc current is extracted, and

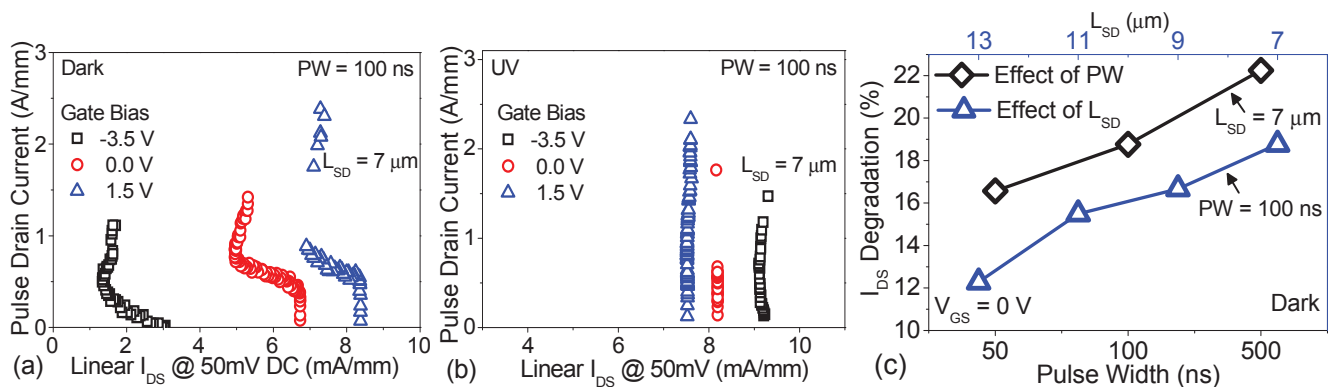
is shown in Fig. 4. Figure 4(a) shows that when devices were stressed under dark condition, the device degraded in a cumulative fashion above a certain critical current. Device degradation, after stress, is known to be due to carrier trapping [2]. This is further validated by experiments under UV exposure. Figure 4(b) shows that device degradation is absent in presence of UV exposure. The trends discussed above can be explained as follows: at higher drain field channel electrons gain sufficient energy to surmount 2D quantum well and get trapped in the surface traps and/or buffer traps, which degrades the device performance under dark condition. UV exposure assists in carrier de-trapping and suppresses the trap originated device degradation. Furthermore, it was found that device degradation linearly increases with PW, due to longer time and higher temperature/ thermal energy available for carrier trapping and it linearly decreases with source to drain distance, i.e. channel field (Fig. 4c). Figure 5a further depicts cumulative nature of device degradation under dark condition, which was missing under UV exposure. Moreover, Fig. 5b reveals that carrier trapping takes at the gate edge and in the drift region, which degrades the Schottky barrier, shifts the threshold voltage and increases the gate leakage and UV exposure de-traps the carriers and minimizes Schottky degradation as clear from Fig. 5c. Given that SOA boundary

Fig. 4: Linear drain-to-source current measured after each pulse stress across the device under (a) dark and (b) UV condition. Unique current degradation trend can be observed after each voltage pulse, under dark condition, which is absent under UV light condition. Negligible degradation in presence of UV light is attributed to carrier de-trapping. (c) Degradation in linear drain current measured at 50 mV DC, under dark condition as a function of pulse width and source to drain spacing.

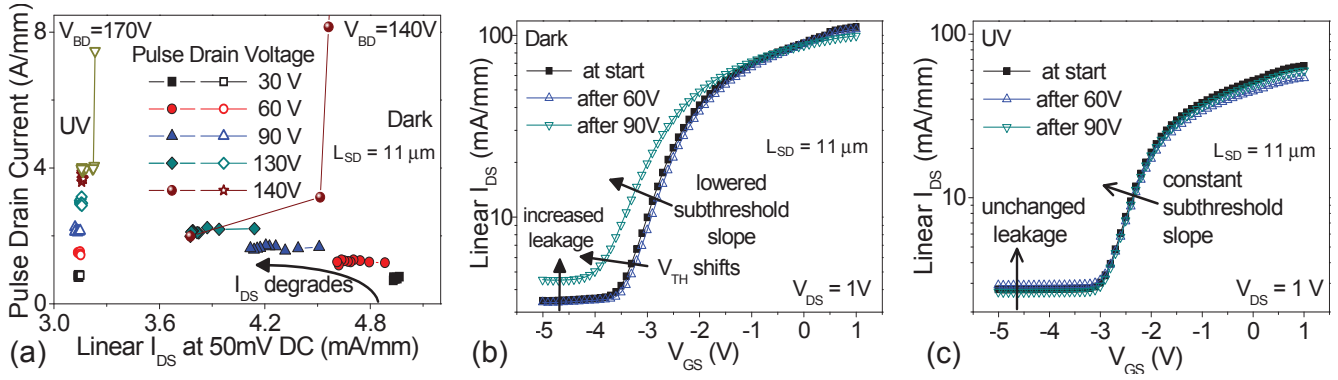
Fig. 5(a) Cumulative degradation extracted by applying set of ten constant voltage pulses before increasing its amplitude. A cumulative degradation is visible under dark condition, which is missing in presence of UV light. (b) DC transfer characteristics measured after stressing device using a set of ten pulses under Dark and (c) UV conditions. In dark condition, device's off-state leakage has increases, threshold voltage and subthreshold slope are affected too, which is absent in presence of UV exposure.

improves, when device degradation was absent, it can be concluded that carrier trapping assists in avalanche instability and early snapback (explained below). At longer stress pulses, independent of device degradation, which was present in both the cases, device fails due to electro-thermal instability.

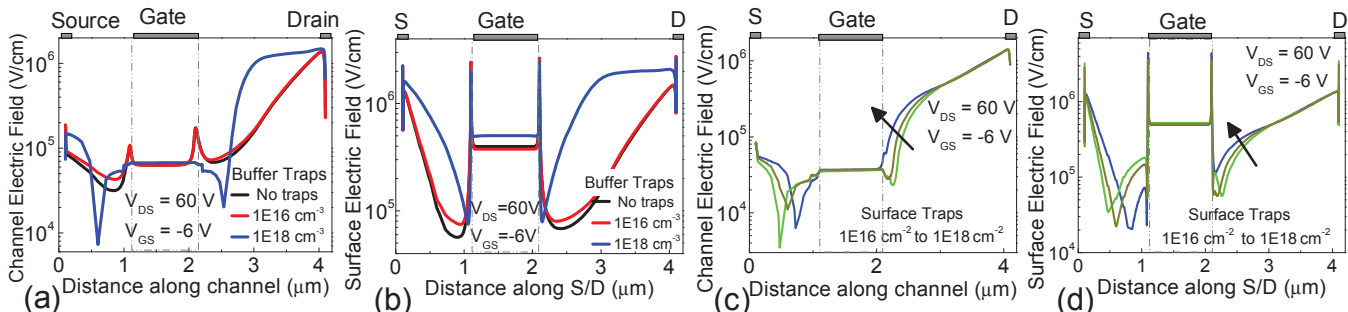
TCAD simulations (Fig. 6) depict shift in surface as well as channel field when buffer traps were increased. Similarly, it reveals that increasing the surface trap density increases the field at the gate edge, both inside the channel, as well as at the surface. Beside the shift in lateral field, for higher buffer trap concentration, field strength also increases under the drain contact. This leads to localized electron – hole pair generation. The excess holes, which are collected at source, form a parasitic path below the GaN buffer (Fig. 7). Due to finite defect density of MOCVD grown GaN/AlGaIn, the trap generation and carrier trapping occurs non-uniformly across the device width. This leads to formation of localized regions, where carrier trapping is higher compared to rest of the device's active region. These regions in turn see an early shift in electric field peak towards drain, which forms localized parasitic path(s). These localized parasitic paths lead to formation of current filament, which is evident as avalanche instability or snapback in the I-V characteristics shown in Fig.8. Beside failure analysis results (presented below), the avalanche instability due to filament formation can be validated from pulse to pulse instability observed in Fig. 8a,

Fig. 6: (a), (c) Channel and (b), (d) surface electric field extracted using TCAD simulations while varying (a), (b) GaN buffer traps and (c), (d) surface traps. When buffer trap conc. was increased the surface and channel fields in gate-drain region increases and peak field shifts from gate edge towards drain. While considering only surface traps, field at the gate edge increases when surface trap concentration was increased.

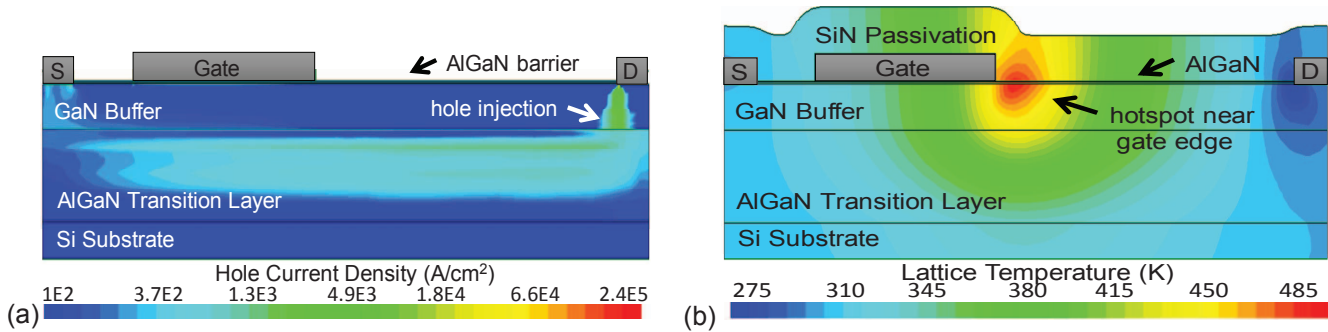
Fig.7 (a) TCAD contour depicting hole distribution at the device breakdown, under -6V gate bias condition. Excess holes generated at near drain edge due to impact ionization are injected into the buffer, which are collected at the source, forming parasitic S/D short path in buffer. (b) Temperature distribution across the device depicting hotspot near drain side of gate edge.

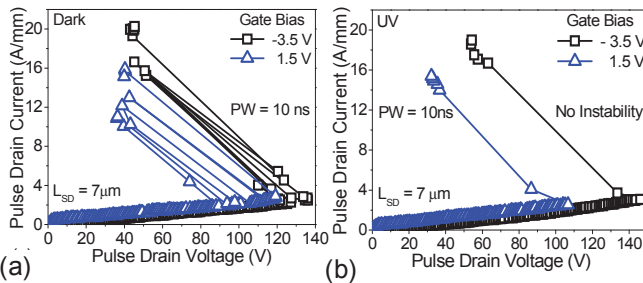
when measured under dark condition. In this case, device forms a filament however, it survives thermal failure due to short duration of applied stress. As a result, device tries to enter into snapback state multiple times, before experiencing a localized thermal fail at higher currents. However, the same instability was absent under UV exposure as shown in Fig. 8b.

Fig. 8: (a) Snapback instability observed in I-V characteristics extracted dark conditions using 10ns PW. This is attributed to electrical instability caused by carrier trapping in different device regions. (b) Absent snapback instability in presence of UV exposure.

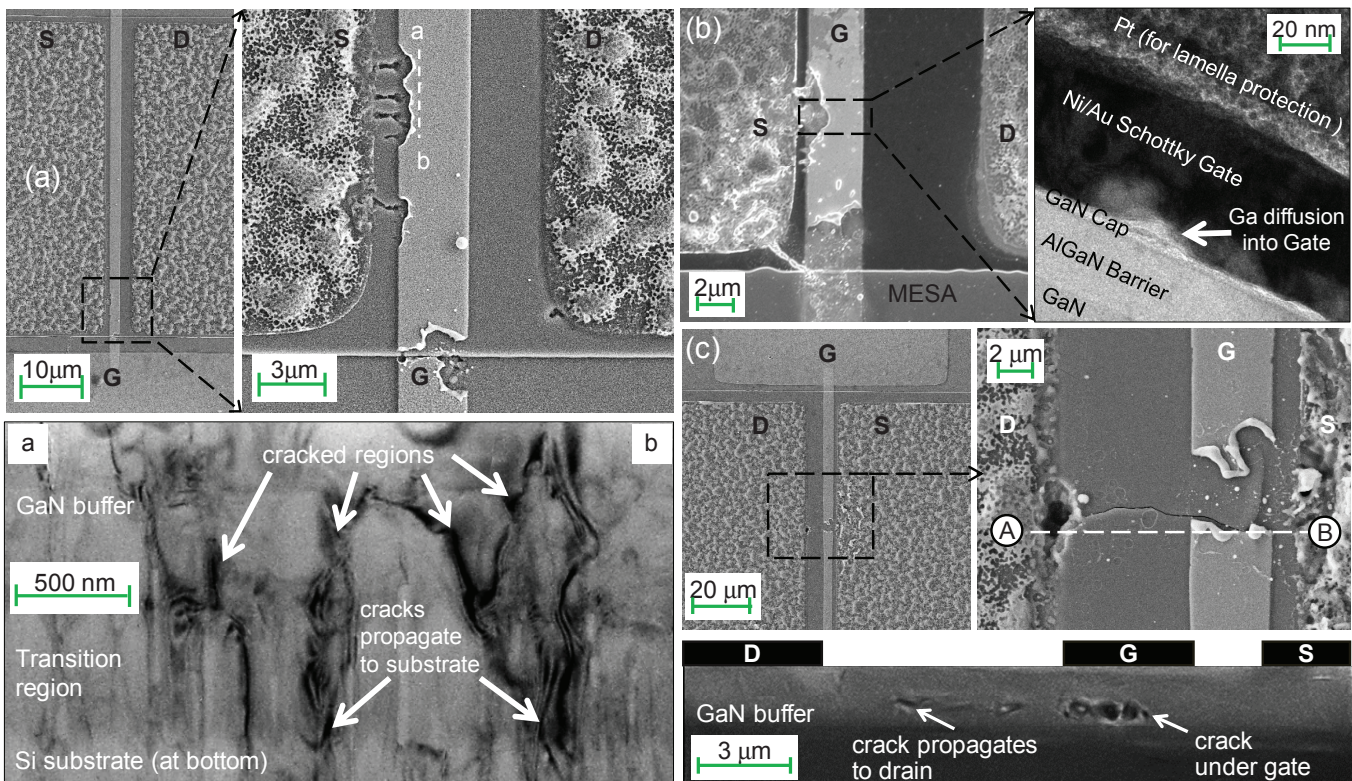
Under dark condition, failure was found to occur in the G/S region (Fig.9a-b), while under UV exposure device was found to fail in G/D region (Fig. 9c). Figure 9a and 9b clearly show multiple failure spots in the G/S region, which is attributed to hole accumulation under gate and formation of localized parasitic/filament paths. This corroborates with the filament and avalanche instability theory presented above. In addition to this, a significant Ga out diffusion under the gate can also be found from TEM pictures (Fig. 9b). As presented above, in absence of traps, i.e. in presence of UV light, the peak electric field lies at gate edge towards drain. This leads to formation of hotspot at the drain side of gate edge (Fig. 7b), generating thermal stress in the vicinity of gate which results in cracking (Fig. 9c). Under the influence of G-D electric field, the crack propagates towards the drain. Hot spot at the gate also peels-off the gate metal (Fig. 9c), which can migrate from gate-to-drain, along the low energy path provided by crack, under the influence of gate-to-drain field.

Fig.9: Post failure SEM and TEM images depicting different types of failures and failure mechanisms dominant during test under dark and UV conditions. (a) HEMT failed under dark condition, stressed using 10ns pulses, shows multiple damage sites in S-G region. Cross-sectional TEM along line 'a-b' depicts cracks running down to buffer region/transition region. (b) HEMT failed under dark condition, stressed using 10ns pulses, shows damage in S-G region and failure at MESA Schottky junction. TEM analysis of damaged region reveals Ga out-diffusion into Ni/Au Schottky gate. (c) HEMT failed under UV condition, stressed using 10ns pulses, shows damage in G-D region. Cross-sectional SEM image taken along line 'A-B' depicts cracks underneath the drain side of gate edge which propagated towards the source.
