Trap Assisted Stress Induced ESD Reliability of GaN Schottky Diodes

Abstract - Electro-thermal behaviour and degradation of recessed GaN Schottky diode are studied under forward and reverse ESD stress. Impact of different surface treatments at Schottky interface, on trap generation and degradation is investigated. Evolution of mechanical stress and defects is probed using on-the-fly Raman spectroscopy. Distinct failure modes are discovered in each case.

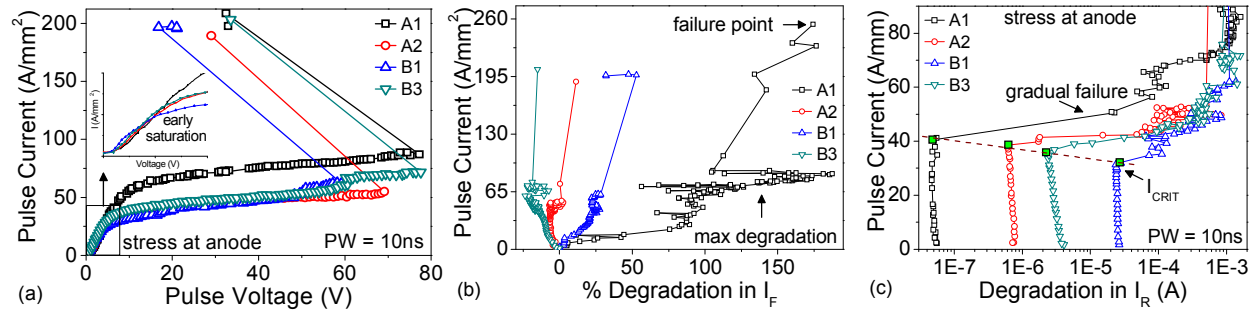
Figure 2: TLP characteristics of recessed diode with different anode surface treatments, when anode is stressed with respect to cathode. (a) A1-diode (with 60s RTA @700 °C) showed improvement in TLP current while B1-diode (with BOE treatment) failed early. (b) Degradation in spot measured forward diode current exhibits maximum degradation in A1-diode. (c) Significant increase in spot measured reverse leakage is noticed and diode suffers soft/gradual failure beyond a critical value of stress current (I_{CRIT}), in each case.

Figure 2 shows a comparison of TLP characteristics under forward stress for diodes processed with different anode surface treatments. Following observations can be noticed; (i) Although diode-A1 (with 700 RTA) has larger V_{CUT-IN} as depicted in inset of Fig.2a, it showed higher TLP current than the diode-A2 (with 500 RTA) which is attributed to its lower R_{ON} and smaller Schottky barrier height (SBH = 0.54eV). (ii) Diode-B1 (with BOE), failed earlier than diode-B3 (without BOE). BOE treatment on GaN increases the surface roughness which translates to increase in D_{it} at Schottky interface [7] Spot measured leakage characteristics are shown in Fig. 2(b)-(c). Forward linear current (I_F) showed negligible degradation in all cases except in diode-A1 as depicted in Fig. 2(b). However, beyond a critical stress current, called safe operating stress current, reverse leakage (I_R) increased by several orders of magnitude in all the cases, are shown in Fig. 2(c). This observation highlights that reverse leakage in GaN Schottky diode is sensitive parameter to capture degradation.

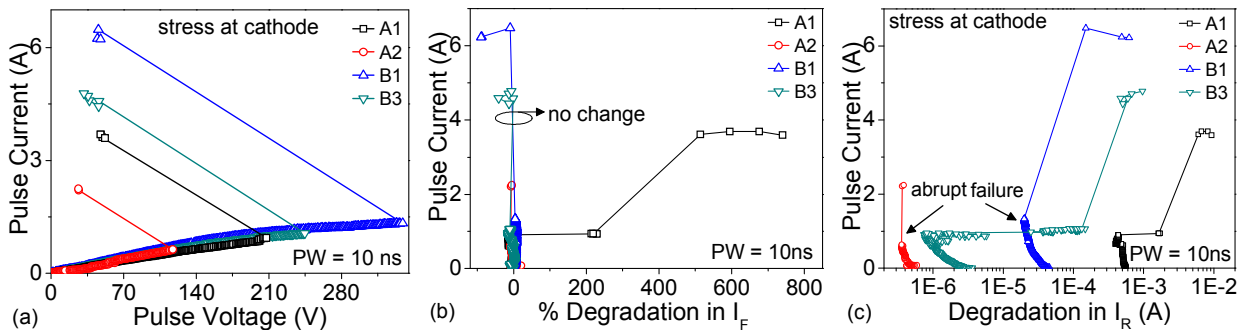
Figure 3: TLP characteristics of recessed diode with different anode surface treatments, when cathode is stressed with respect to anode. Interestingly, linear TLP characteristics are observed under 10 ns pulse width. Figure reveals; diode with BOE treatment (B1) exhibited much higher robustness (V_{SNAP}) than diode without BOE treatment (B3). (b) No significant change is noticed in spot measured forward diode current, except for diode-A1. However, the spot measured reverse leakage followed unique degradation trend as shown in (c) and the diode faced abrupt failure beyond a critical value of stress current in each case.

Next, the diodes were tested under reverse mode, with cathode positive stressed and anode grounded. Figure 3 shows the TLP characteristics of different types of diodes under test. Figure 3(a) reveals the following; (i) Linear TLP characteristics are observed in all the cases. (ii) Diode-A1 (with 700 RTA) and diode-B1(with BOE) exhibited higher robustness than diode-A2(with 500 RTA) and diode-B1(with BOE) respectively. The corresponding spot measurement results are summarized in Fig. 3(b)-(c). As observed in Fig. 3(b), forward spot linear current remained unchanged like that under forward-mode stress. However, reverse spot leakage degraded significantly. But, unlike in forward-mode, its degradation happened from the very beginning of the stress. And beyond a critical stress current, it increased abruptly on device failure.

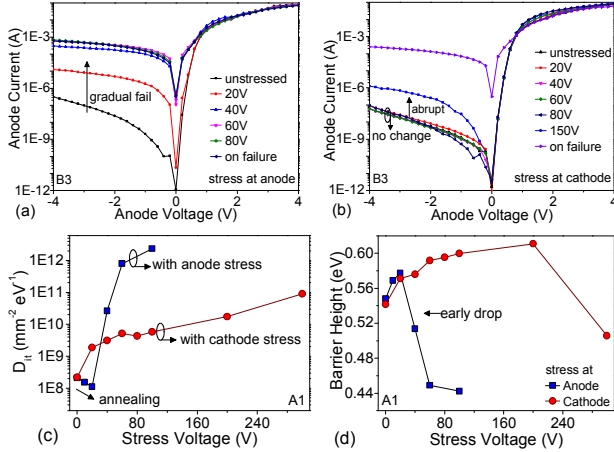
Figure 4: DC I-V characteristics of DUT measured during a 10 ns TLP stress test (a) applied at anode shows gradual change from Schottky to Ohmic nature. While TLP stress (b) applied at cathode induces abrupt device failure with three orders increase in reverse leakage. Interface defect density and barrier height at Schottky junction show significant change with stress, in each case. (c) TLP stress at cathode, causes gradual increase in D_{it} while such increment is rapid when TLP stress is at anode. As a result, Schottky barrier height degrades early for TLP stress at anode as in (d).

DC characterization of devices is done at regular intervals during the stress, to gain physical insight into mechanism responsible for ESD failure of GaN Schottky diode. Figure 4 summarizes the obtained results. As depicted in Fig. 4(a), Schottky diode degraded gradually with constant increase in reverse leakage under forward-stress and anode contact gradually changes from Schottky to Ohmic. However, under reverse stress, the dc characteristics remained intact until the abrupt device failure occurred. Same behaviour was observed in all the cases. Therefore, it is discovered that GaN diode undergoes soft failure under forward stress and it fails abruptly under reverse mode stress.

To understand the root cause of these distinct failure modes, Schottky barrier height (SBH) and interface defect density (D_{it}) were monitored during stress under forward and reverse mode. Figure 4(c)-(d) shows the variation in D_{it} and SBH recorded in device under stress. As depicted in Fig. 4(c) diode under forward ESD stress, saw initial drop in D_{it} which is attributed to thermal annealing of the interface defects at high forward current [8]. Beyond a certain stress current value, called safe operating stress current, an increase of 4 orders is recorded in D_{it} . The increased D_{it} gradually deteriorates SBH from 0.58 eV to 0.44 eV which induces gradual increase in dc reverse leakage (Fig. 4a) and spot leakage (Fig. 2c) according to the Schottky diode equation;

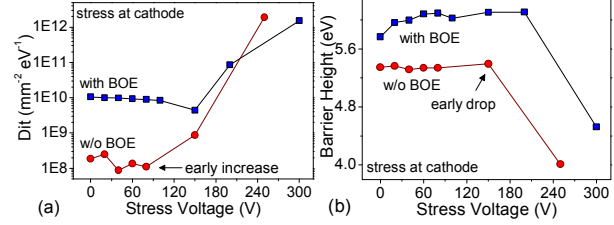
Figure 5: Health of Schottky interface is monitored at regular intervals during the stress. (a) Diode processed with pre-BOE treatment exhibits higher D_{it} that diode without BOE treatment. However, diode without BOE treatment, shows early increment in D_{it} which lowers SBH at much lower stress voltage as in (b).

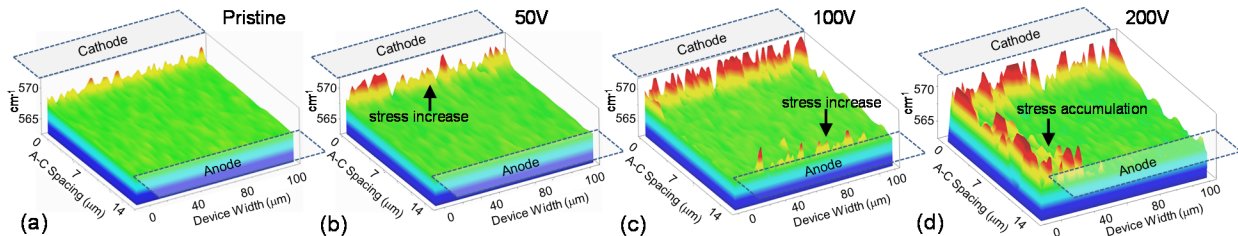
Figure 6: (a) Raman map captured in anode-cathode region of pristine diode, before stress. Figure reveals residual compressive stress at cathode edge. On the fly Raman map was captured during reverse-mode ESD stress (b) at 50V, (c) at 100V and (d) at 200V stress on cathode. With increasing ESD voltage, compressive stress accumulates at edge and corner(s) of recessed anode.

GaN/AlGaN material system possess intrinsic piezoelectric nature which poses reliability challenges at high voltages. In present study, the evolution of mechanical stress in DUT captured on the fly during ESD stress using 2D Raman mapping revealed interesting failure physics under reverse mode ESD stress. Figure 6 shows, the evolution of

mechanical stress in anode-cathode region with increasing TLP stress at cathode. Raman map of pristine device as shown in Fig. 6a before stress, reveals residual compressive stress present at cathode which possibly originates from CTE mismatch between cathode metal stack (Ti/Al/Ni/Au) and underlying AlGaN, after post metal deposition anneal. 2D Raman maps shown in Fig. 6(b)-(d), reveal that with increase in ESD voltage, the compressive stress builds up at the recessed anode edges and corners. This explains why failure occurred at recess edges in diodes under reverse ESD stress as shown in Fig. 7(a)-(b). Therefore, ESD failure of GaN Schottky diode under reverse mode, is governed by the piezoelectric stress distribution, hence exhibits field dependent failure.

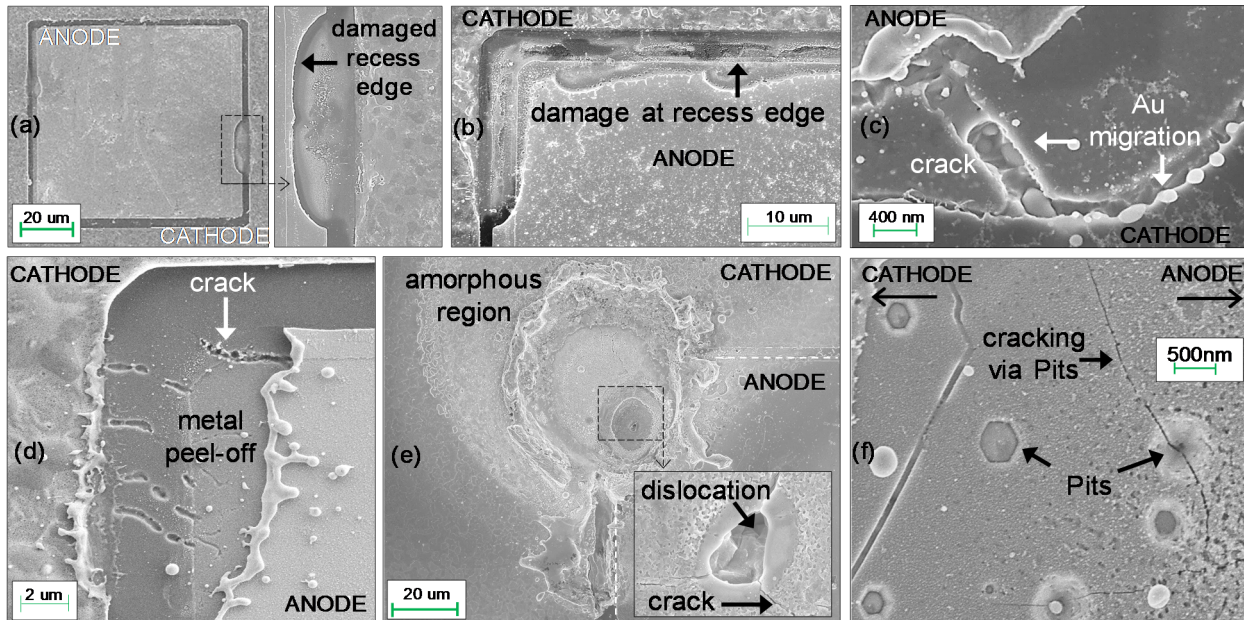
Figure 7: (a) SEM image of diode damaged under 10 ns TLP stress applied at cathode. Damage at anode recess edge is visible. No traces of metal melting/ migration observed which highlights non-thermal nature of the failure. (b) Diode failure at anode recess edge under reverse mode stress. (c) SEM image of diode failed when stressed at anode. Massive crack is seen at anode contact corner with metal migration. EDX analysis confirms Au migrated from anode to cathode edge. This observation reveals thermal nature of the failure on on-state failure. (d) Post failure image of diode which failed under forward mode ESD stress. Multiple cracks at anode corner possibly occurred due to high fringing field. Also, anode metal melting and peel-off confirms electrothermal failure. (e) Post failure SEM image of diode-A2, with damaged region between anode and cathode. Magnified view shown in Inset, reveals dislocation induced cracking and consequent diode failure. (f) Image of another failed A2-diode, shows a network of pits/dislocations which provided path form crack propagation.

After TLP testing, failure analysis of ESD damaged regions of diodes was done to gain physical insight into the degradation mechanism(s). Figure 7 shows post failure SEM micrographs of device failed

under different stress conditions. Figure 7(a) SEM image of diode-A2 damaged under TLP stress applied at cathode. The damage occurred at anode recess edge with no traces of metal melting/migration observed. Figure 7(b) shows image of diode-B3 with similar damage at anode edge. This observation highlights the universal nature of failure mechanism and is independent of Schottky interface quality/treatment under reverse mode ESD stress. The absence of metal melting/folding and migration in failed regions reveals the non-thermal nature of the failure and points to field dependent failure. Figure 7(c) SEM image of a diode which failed under forward ESD stress. Massive crack can be seen at anode contact corner with metal migration. EDX analysis confirms Au (14%) migrated from anode to cathode edge. This observation reveals thermal nature of the failure. Post failure SEM image of diode-A1 which failed under forward stress shows multiple cracks at anode corner due to fringing field. Also, anode metal melting and peel-off further confirms electrothermal device failure. Pits and dislocations

can also nucleate the cracks in anode-cathode region, as seen in Fig. 7(e)-(f).
