On the ESD Behavior of a-Si:H based Thin Film Transistors: Physical Insights, Design and Technological Implications

Rajat Sinha^{1,2}, Prasenjit Bhattacharya², Sanjiv Sambandan² and Mayank Shrivastava¹
¹ Mayank Shrivastava's Devices Lab ² Flexible Electronics Lab,
 Indian Institute of Science, Bangalore, India. Email: mayank@iisc.ac.in

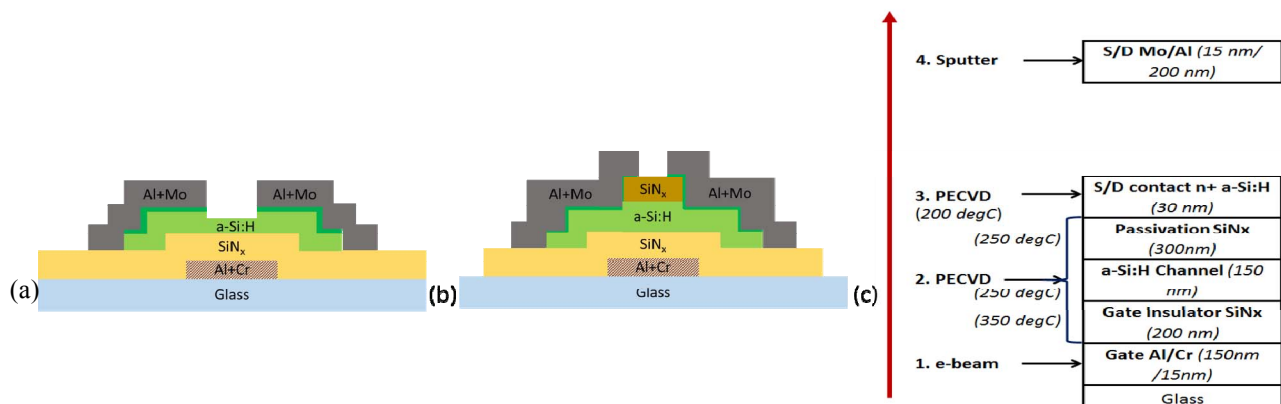
Fig.1: Cross-sectional view of (a) Back Channel Etched (b) Back Channel Passivated TFT used in this work. (c) Depicts the process flow followed in this work to realize BCP TFT devices under test.

Fig.1 shows the cross-section of back channel passivated and back channel etched TFTs used in this work. Corning glass, cleaned using Piranha Solution is used as the substrate. The fabrication process begins with e-beam evaporation of Al/Cr on corning glass, followed by its patterning using wet etching, which serves as a gate electrode. Post-metallization of gate electrode, a series of PECVD based processes are carried out to deposit 200nm thick SiN_x, a 150nm thick a-Si:H layer and 300nm thick SiN_x, where the a-Si:H acts as channel, while SiN_x layers act as gate dielectric and channel passivation respectively. Following the patterning of passivation layer, a 30nm thick n-doped a-Si:H layer was deposited using PECVD. Subsequently, the active layer and the gate insulator were patterned using RIE. The source/drain electrodes (Mo/Al) were deposited using DC sputtering and patterned by wet etch. Finally, RIE was employed to etch-out the n-doped a-Si:H layer from the channel region. The devices were annealed at 423K for a period of 1hr before characterization. ESD characterization was done using a 50Ω TLP setup. A current sensor with a sensitivity of 0.5mV/mA and a 4 GHz Oscilloscope are used to capture waveforms. The setup was

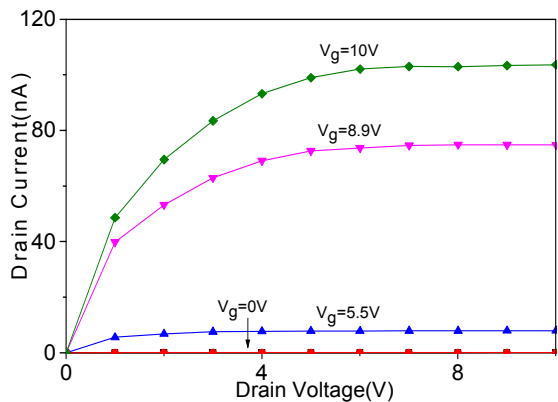
Fig 2: DC I-V characteristics of a-Si:H TFTs. S/D form ohmic contact with a-Si:H due to n⁺ a-Si:H layer. On/Off ratio is >10⁴ and threshold voltage is approximate 4V.

calibrated using a standard surface mount resistor and a zener diode. Unless stated otherwise, grounded gate devices were stressed with a pulse, of time period 100ns and rise time 10ns. To study failure, a low DC bias is applied after each pulse and drain current was monitored. Exploration of device degradation and changes in material properties was done by on-the-fly I-V, C-V and Raman Spectroscopy measurements after ESD stress pulses. DC I-V measurements between stress pulses were done for a lower voltage range so as to avoid device degradation. On-the-fly Raman spectroscopy was done using 532nm laser with a spot size of 1 μ m. Fig. 2 shows DC I-V characteristics of devices under test.

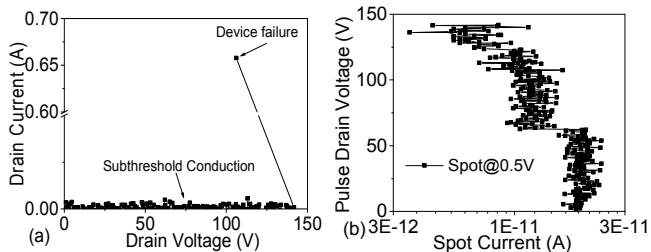
Fig. 3: (a) TLP I-V and (b) Spot current characteristics depicting breakdown and degradation behavior of TFTs. Due to low mobility of a-Si:H, TLP current is immeasurably low. Spot characteristics show that degradation sets in after 60V stress.

The TLP characteristics of a-Si:H TFTs shown in **Fig. 3** depicts two modes of operation – (1) sub-threshold conduction, where the device shows a linear operation with high on-resistance; (2) device failure, characterized by voltage snap-back and sudden increase in TLP current (**Fig. 4**). Due to high on-resistance, the drain current is immeasurably low. The device failure takes place in steps with localized failure spot spreading across the channel width. **Fig. 5** shows the SEM image of a failed device with localized failure spot. In some devices, complete channel failure is also observed. Spot measurements (**Fig. 3**) show that device degradation starts only after 60V, which forms the threshold of degradation.

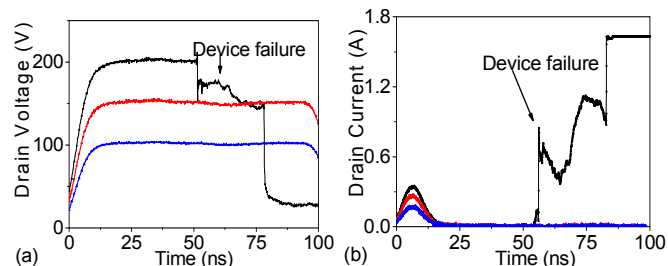
Fig. 4: Transient (a) TLP Voltage and (b) TLP current characteristics extracted from 100ns pulse stress. The device failure is characterised by transient drop in drain voltage and corresponding increase in drain current, which takes place gradually in steps until the channel experiences a completely failure.

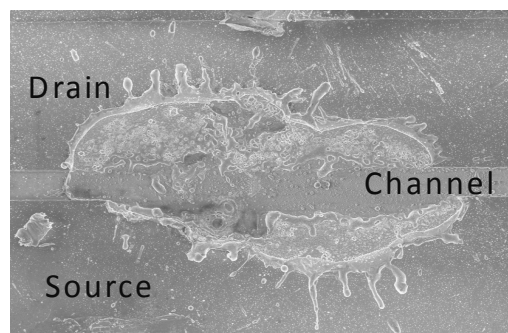
Fig. 5: Post failure SEM micrograph of TFT device with partially damaged channel. Damage occurs locally in the channel region which creates a short between source and drain. Due to excess current, post failure, contact melting also takes place.

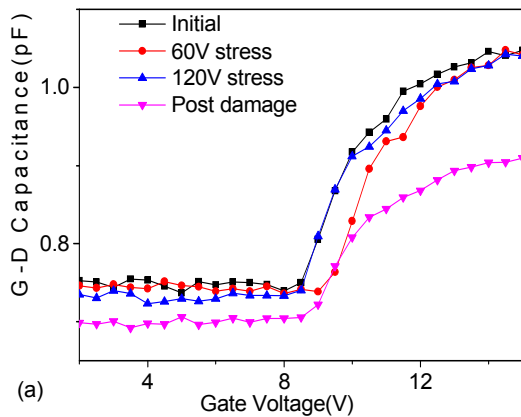
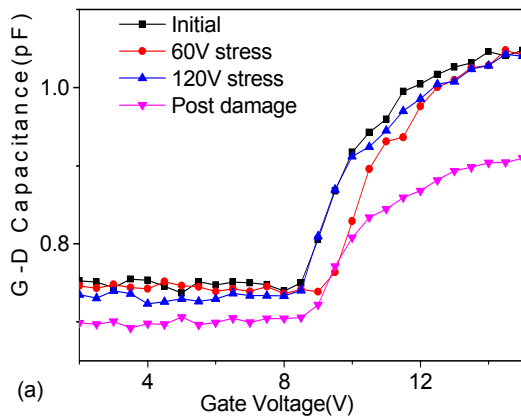
Fig. 6: C-V characteristics of a-Si:H TFTs before and after applying ESD stress. (a) Gate-Drain capacitance and (b) Gate-Source capacitance measured at 1MHz. A parallel shift in C-V characteristics, in both cases, is visible after 60V stress, which at the drain side recovers to initial value after 120V stress, while the source capacitance continues to shift in the same direction. This is due to generation of excess electrons near the drain contact at higher stress voltages, which masks the effect of charge trapping at gate.

I-V, C-V and Raman characterizations were performed to understand the pre-breakdown degradation mechanism. Following changes can be observed after a stress voltage of 60V (**Fig. 6 and 7**): (i) degradation in drain current (ii) increase in threshold voltage (iii) a shift in C-V characteristics. These behaviors can be attributed to injection of charge carriers, i.e. electrons, into the gate dielectric. Injections of electrons lead to an increase in threshold voltage

and causes shift in C-V characteristics. It is also observed that as the stress increases to 120V, the gate-drain capacitance and drain current has turned around to initial values although a similar trend is not observed on source side. This can be explained by selective compensation of charge trapping in dielectric on the drain side of channel. Excess electrons generated during impact ionization are swept to drain and mask the effect of electrons trapped in dielectric. In the pre-breakdown regime, there is no change in the Raman signature, thus the device shows no material change in channel region (**Fig. 8**). The device failure occurs either due to avalanche breakdown in the channel or due to dielectric breakdown. Post-damage, it is observed that the Raman peak is shifted to 515 cm⁻¹, showing a shift towards higher

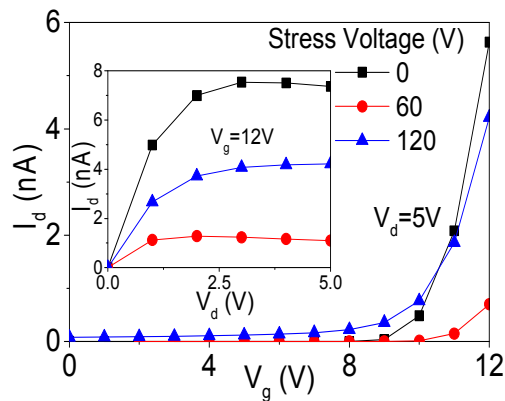
Fig. 7: DC I-V characteristics (I_d - V_d in Inset) depicting device degradation before permanent failure. Performance recovery from 60V to 120V takes place due to generation of excess electrons near drain contact.

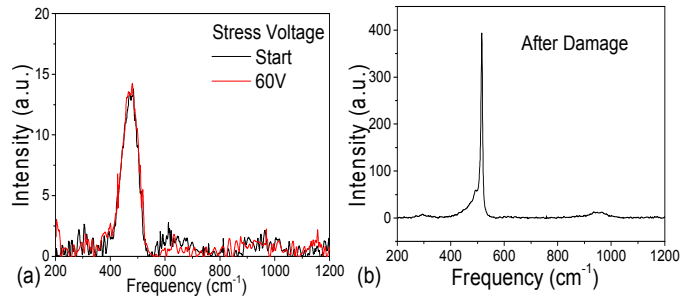
Fig. 8: Raman spectra (a) Before and (b) After, device failure. There is no shift in Raman signal with stress before the permanent device failure depicting absence of material change as a function of stress. Post damage, Raman peak shifts to 515cm^{-1} , depicting a change from amorphous to near-crystalline nature of Si, possibly due to excessive channel heating during device failure.

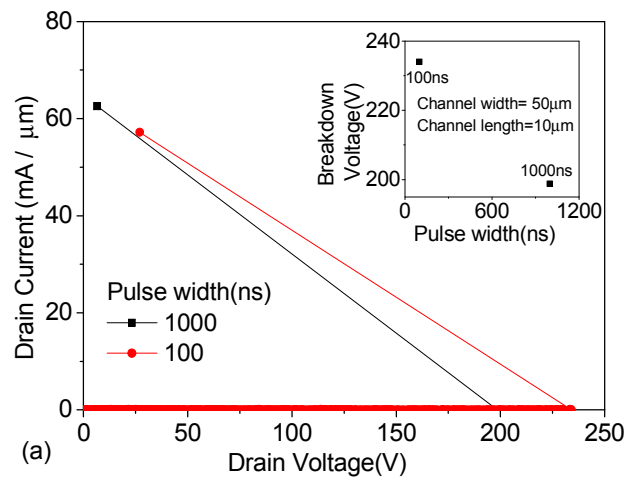
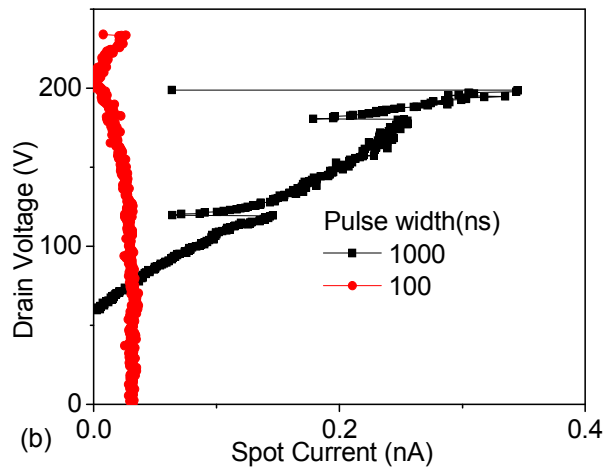
Fig. 9: (a) TLP I-V characteristics with different pulse widths and (b) spot measured drain current vs pulse/stress drain voltage. Fall in failure voltage with TLP pulse width (inset) depicts thermal nature of device failure. Increased device degradation in case of 1000ns pulse stress when compared with 100ns stress depicts self-heating assisted trap generation and device degradation during ESD stress.

To study the thermal nature of breakdown, devices were stressed with pulse widths of 100 and 1000ns. It is observed from **Fig. 9** that breakdown voltage reduces with pulse width.

Reduction in breakdown voltage with increase in pulse widths points towards thermally-assisted breakdown behavior. Increase in channel temperature leads to de-trapping of electrons in a-Si:H, leading to an increased concentration of electrons in channel, thus favoring avalanche breakdown. Higher temperature also aids avalanche breakdown leading to a reduction in breakdown voltage with pulse width. Channel dimensions play an important role in determining the failure mechanism. To explore the effect of channel dimensions on breakdown, devices with varying device channel dimensions were characterized (**Fig. 10**). It is observed that as channel length increases, breakdown voltage initially increases and then saturates. It is also observed that as channel width increases, breakdown voltage initially remains constant and then decreases. These behaviors can be explained as follows: For relatively smaller dimensions, punch-through leads to device failure, leading to dependence of breakdown voltage on channel length but not channel width and for larger dimensions, dielectric breakdown dominates. Devices with a

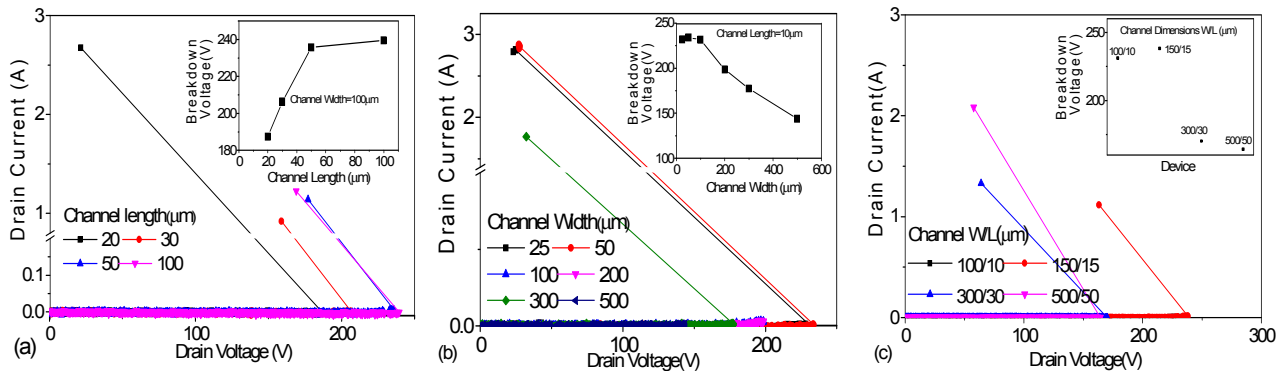
Fig. 10: TLP characteristics as a function of channel dimensions. (a) Variation of Channel length, (b) Variation of Channel width and (c) Variation of Width/Length ratio, while keeping the ratio constant. For smaller channel length punch through dominates the breakdown/turn-on and failure, while for larger dimensions dielectric breakdown dominates the catastrophic failure. For devices with constant Width/Length ratio, failure threshold didn't follow a unique trend. For smaller widths, it improves with channel length, however for larger widths it lowers due to increased probability of failure along the width.

constant width/length ratio have varying breakdown voltages. This is caused due to difference in actual device dimensions and hence, failure mechanism. Gate field dependency is studied by biasing gate voltage during ESD characterization. Observations in Fig. 11 can be explained by dielectric breakdown mechanism in those devices.

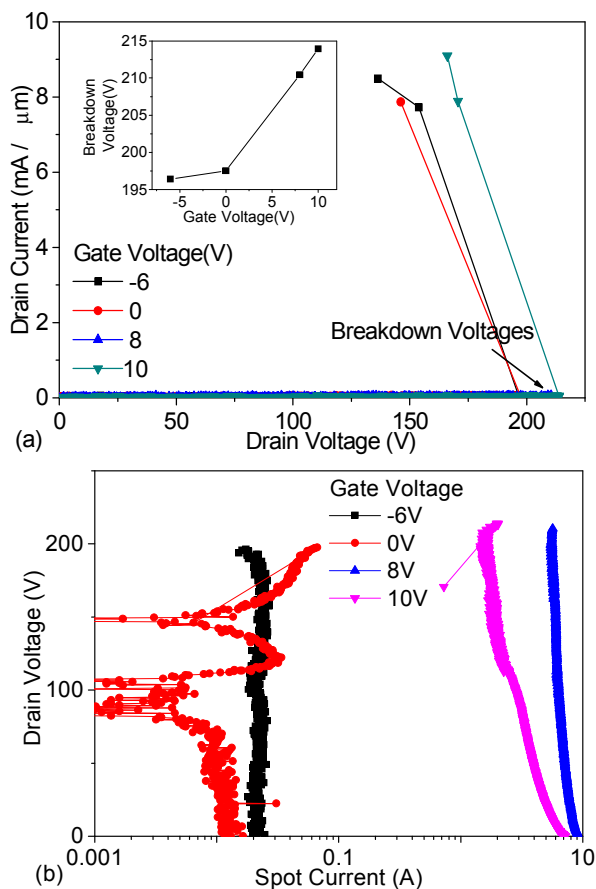
Fig.11: Effect of gate field on the ESD behaviour. With increase in gate bias, breakdown voltage increases in such a way that gate-drain field at breakdown remains constant. Device shows performance degradation and recovery only for $V_G=0V$ as under accumulation hot electrons in the channel are repelled away from gate and under inversion condition, inversion charge masks the excess electron presence near drain.

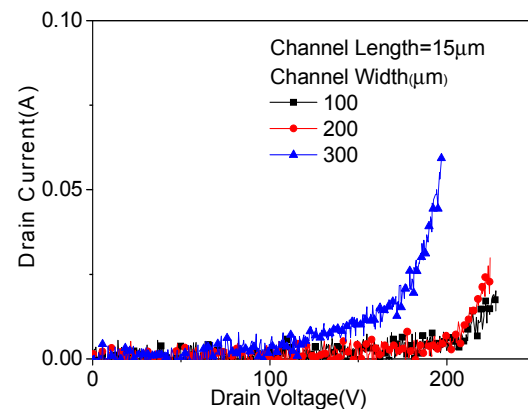
Fig. 12: TLP I-V characteristics of gated diode devices. Gate coupling leads to a lower failure voltage, although improvement in failure current is also observed. This is due to increase in carrier concentration in channel with drain voltage, thereby aiding avalanche breakdown.

ESD behavior of FinFet based Gated diodes has been well explored [9], [10] while a similar exploration is still lacking for a-Si:H based Gated diode. Fig. 12 shows the TLP I-V characteristics of a-Si:H based gated diodes. Gated diodes offer higher failure current but a lower failure voltage as compared to a typical TFT. This is due to higher concentration of charge carriers in channel aiding avalanche breakdown. ESD behavior of drain underlap devices has been studied by measuring devices with varying dimensions. Two-terminal a-Si:H resistors play an important role in a-Si:H technology and have been used in a-Si:H based circuits [11]. Fig. 13 shows the TLP I-V characteristics of a-Si:H based resistors. These devices undergo avalanche breakdown and the breakdown voltage shows saturation with channel dimensions Fig. 14 shows the TLP I-V characteristics of drain under-lap TFTs. It can be observed that drain underlap devices provide improved ESD robustness as compared to typical TFTs. This behavior can be attributed to electric field relaxation provided by drain underlap region, which reduces the maximum electric field under the drain edge and hence improves ESD robustness. On account of their improved ESD robustness, drain underlap devices can be used as I/O protection elements in a-Si:H technology..

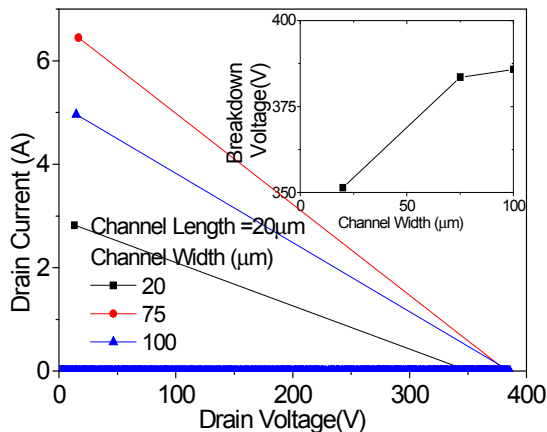
Fig. 13: TLP I-V characteristics of a-Si:H resistors. Breakdown voltage vs channel width (inset). Resistors fail due to avalanche breakdown occurring in the channel region. Breakdown voltage also increases up to a critical channel length and then saturates.

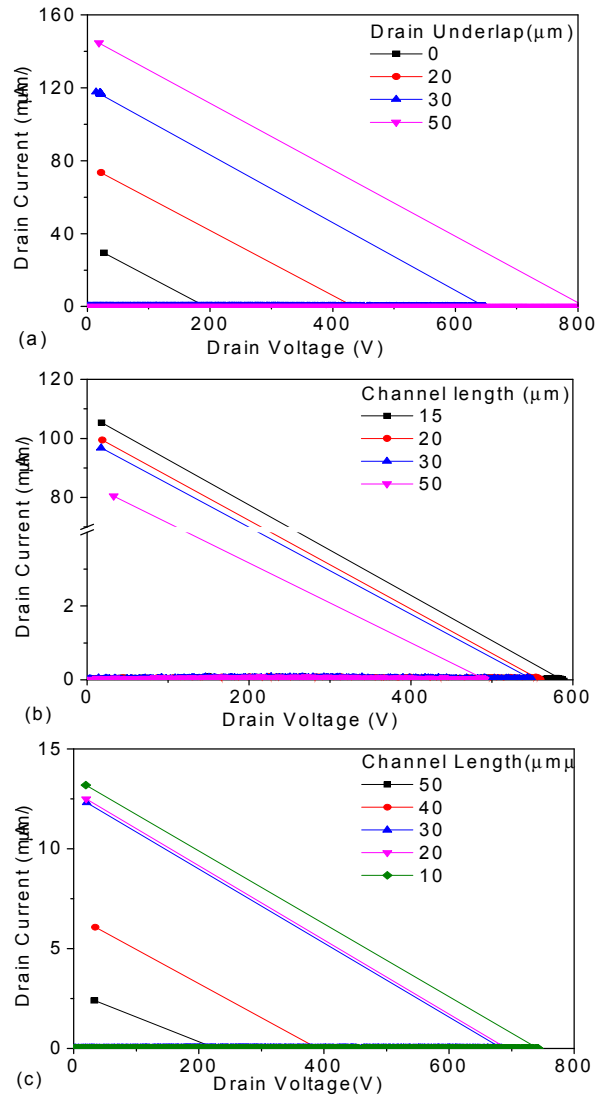
Fig.14: TLP I-V characteristics of various Drain Underlap device structures (a) Constant channel length, (b) Constant drain underlap length and (c) Constant Source-Drain length. Drain underlap devices provide high ESD robustness and can be used as I/O protection devices in a-Si:H technology.
