First Observations on the Trap-Induced Avalanche Instability and Safe Operating Area Concerns in AlGaN/GaN HEMTs

Abstract—This paper reports the very first systematic study on the physics of avalanche instability and safe operating area (SOA) reliability in AlGaN/GaN high-electron-mobility transistor (HEMT) using submicroseconds pulse characterization, poststress degradation analysis, well-calibrated TCAD simulations, and failure analysis by scanning electron microscopy (SEM) and transmission electron microscopy (TEM). Impacts of electrical and thermal effects on SOA boundary and avalanche instability are investigated. Trap-induced cumulative nature of degradation is studied in detail. The root cause for avalanche instability in AlGaN/GaN HEMTs is investigated. Postfailure SEM, energy dispersive X-ray (EDX), and TEM analysis reveal distinct failure modes in the presence and absence of carrier trapping.

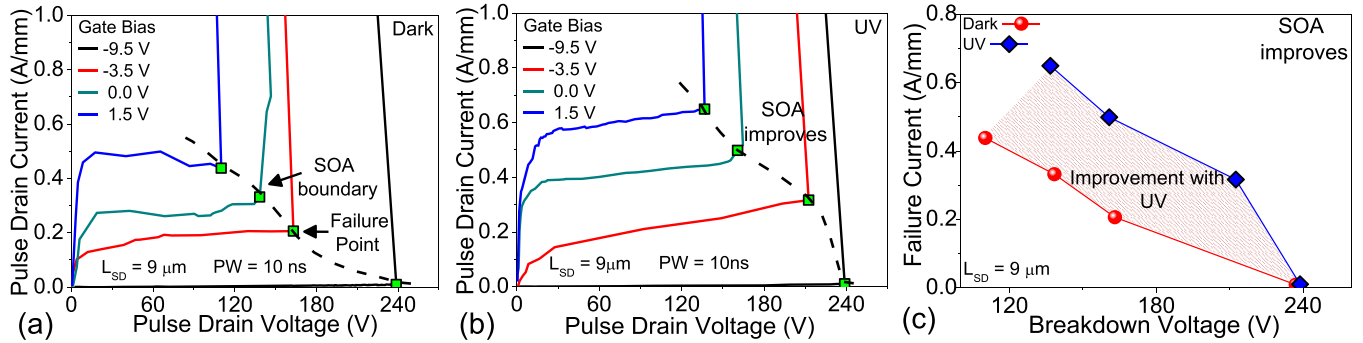
Fig. 1. Pulse I - V characteristics of HEMT (a) under dark condition and (b) with UV exposure. Failure point shown here marks the SOA boundary. (c) Variation in SOA boundary of HEMT stressed under dark and UV condition. As evident, SOA boundary of device widens under UV light.

A device (L_{SD} 9 μm) is tested at 10-ns PW, under dark and in UV light condition. Corresponding pulse I - V characteristics are shown in Fig. 1. As shown in the figure, the device breakdown is marked with an abrupt increase in pulse drain current at the failure point. The locus of the failure point over the entire family of curves marks the SOA boundary of the device. A comparison of I - V characteristics obtained under dark and UV, shown in Fig. 1 unveils the following: 1) early saturation in drain current and 2) early device failure when tested under dark. As a result, the SOA shrinks under dark condition. When the experiment is repeated under UV light, no current collapse is shown and the drain current exhibits quasi-saturation behavior as depicted in Fig. 1(b). The device fails at higher voltage and current, exhibiting broader SOA. Fig. 1(c) shows the comparison of the SOA boundary of a device extracted under dark and UV. As evident, SOA boundary widens under UV light. Under normal device operation, excessive carrier trapping in gate-drain region causes drain current collapse [9]. Trapping underneath the gate can alter threshold voltage [7], while trapping at AlGaIn/GaN interface [10] and in buffer increases R_{ON} [11]. Trap-induced effects degrade device performance, and carrier trapping further increases after degradation [10]. This positive feedback loop continues until the device sees catastrophic breakdown, which is discussed in the next section. The exposure of subbandgap UV light potentially detraps carriers from shallow and deep defect levels present in different regions of the device. Therefore, UV light suppresses trap-induced degradation in the device and improves device SOA. To summarize, the SOA boundary of GaN HEMT is limited under normal operating condition and it gets recovered with subbandgap UV exposure.

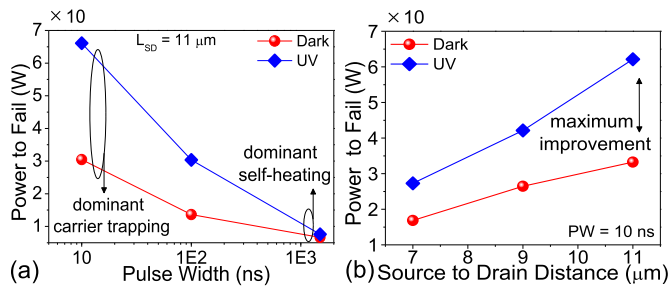
Fig. 2. (a) Power to fail as a function of PW extracted under dark and UV condition. While exhibiting power law behavior presence of UV improves power to fail at shorter pulses. (b) Power to fail as a function of source–drain spacing. It increases linearly with L_{SD} and shifts upward with UV exposure.

time, before permanent failure. Here, power-to-fail (P_{FAIL}) is defined as; $P_{FAIL} = I_{FAIL} \times V_{BD}$, where I_{FAIL} is the failure current and V_{BD} is the breakdown voltage. The study is done to understand, how the failure threshold of GaN HEMT changes with stress conditions and device design parameters. A device is stressed at different PWs and P_{FAIL} is measured in each case under dark and UV exposure. Fig. 2(a) shows the variations in P_{FAIL} recorded under different PWs. P_{FAIL} is observed to decrease consistently with an increase in stress time or PW, exhibiting a power law like behavior, both under dark and UV exposure condition. It is worth highlighting that at lower PW (10 ns), P_{FAIL} shows 2× improvement in the presence of UV due to dominant carrier detrapping from barrier and buffer regions, with minimal self-heating. However, the improvement obtained with UV, gradually falls with an increase in PW. Ultimately, at 1000-ns PW, UV exposure shows no change, consequently P_{FAIL} under dark and UV remains the same. Possibly, at higher PW, the thermal effects originating from self-heating are dominant, which overshadow any contribution from trapping/detrapping as discussed above. This is verified from the postfailure analysis of the devices that show the signature of thermal failure at higher PW as discussed in Section IV. Next, devices of different L_{SD} are tested at the same PW. Fig. 2(b) shows the variations recorded in P_{FAIL} with L_{SD} . Linear scaling of P_{FAIL} with L_{SD} is observed. Large L_{SD} has two complementary effects. On the one hand, the effective channel field, for a given drain voltage, reduces at larger L_{SD} , which suppresses the field-driven degradation phenomena such as trapping and inverse piezoelectric effects. On the other hand, larger L_{SD} offers an increased number of defect states across the larger gate-to-drain region, which increases the number of free electrons captured by the trap states resulting a steeper device degradation. This is verified by the fact that under UV light, the maximum improvement in P_{FAIL} is noted in device with largest L_{SD} (11 μm), which is due to the maximum detrapping under UV exposure.

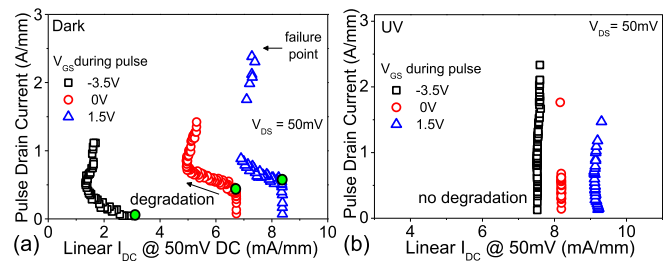
Fig. 3. (a) Linear drain-to-source current measured after each stress pulse of 100-ns duration applied at drain of a device of L_{SD} 7 μm under (a) dark and (b) UV condition. Unique current degradation trend can be observed under dark condition at different gate biases, which is absent under UV illumination.

applied at drain (V_P). Fig. 3(a) shows the degradation trend in I_{dc} observed under dark condition for different gate biases. It shows that at negative gate voltage (here -3.5 V), when the device is under pinched-off condition, device degradation initiates (as marked by green dot) at lower stress voltages/currents. On the other hand, at under ON-state ($V_{GS} = 0$ and 1.5 V), the onset of device degradation (as marked by green dot) was pushed to higher voltages/currents. This shows the requirement of a critical field in gate–drain region for the device to degrade. With increasing drain stress voltage, the electric field in gate–drain region increases which enhances electron injection from gate to surface and channel to GaN buffer. This reduces 2DEG density to obey vertical charge neutrality and results in a drop in drain current. It should be noted that SOA measurements demands application of ultrahigh voltage, short duration (sub-200 ns) pulses between drain–source terminals of GaN HEMT, under ON-and OFF-states, which would eventually lead to HEMT's failure. At these high voltages, the device would lead to excess hot electron generation via impact ionization (II), which rapidly increases the drain-to-source current beyond typical HEMT's drain current (~ 1 A/mm). Since the stress pulse duration is in the sub-200-ns range, the electron-phonon scattering due to self-heating or increased phonon population, which can lower the carrier energy and bring the current back to the nominal range (~ 1 A/mm) is largely missing. This behavior explains very high drain current shown in Figs. 3 and 11, which are extracted using pulses applied for 100 ns or lower. Moreover, the excess carrier holes generated from II can potentially deteriorate the gate control, as discussed in the subsequent sections. Furthermore, under ON-state with increased drain voltage, the hot electron density in channel increases. Hot electrons activate traps at AlGaN/GaN interface [12] and further deteriorates I_{dc} . When the same experiment was performed under UV condition, no degradation in device's dc behavior was observed, independent of gate voltage, as depicted in Fig. 3(b). This hints the role of trap states in device degradation. It is worth highlighting, before explaining these trends further, that UV irradiation is expected to detrapp all the captured electrons from the deep acceptor trap levels. It is to be noted that a delay of 200 ms is introduced between two consecutive pulses. However, the slow detrapping from deep levels can take several seconds to hours for recovery. In the present case, as I_{dc} degrades monotonically under the dark condition with each pulse, it can be concluded

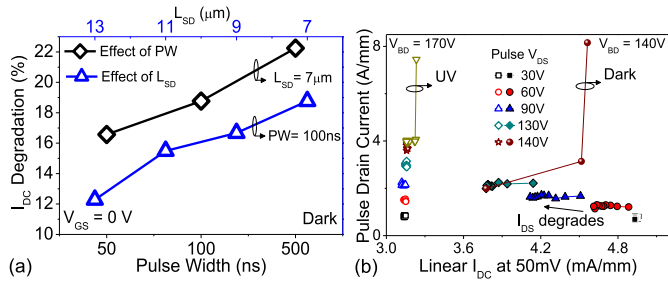
Fig. 4. (a) Degradation in linear drain current measured under dark condition as a function of PW and source-to-drain spacing. (b) Cumulative degradation extracted by applying set of ten constant voltage pulses at drain before increasing its amplitude. A cumulative degradation is visible under dark condition, which is missing in the presence of UV light.

The degradation trends discussed above can be explained as follows: at higher drain stress, hot electrons in channel generate new defects and get trapped at the surface, in barrier and buffer regions. This is responsible for the degradation in device performance. With UV exposure, carrier detrapping gets enhanced which assists in suppressing the trap originated device degradation. Stress experiments done at different PWs show that degradation increases linearly with PW, due to longer stress time available for carrier trapping. Furthermore, percentage degradation is extracted for devices with different source-to-drain spacings which are tested under the same pulse condition (100 ns). Percentage degradation is found to decrease linearly with L_{SD} , as shown in Fig. 4(a), which is attributed to the reduced channel field at larger L_{SD} .

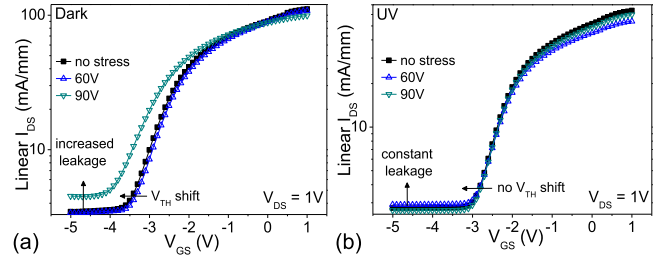
Fig. 5. (a) DC transfer characteristics measured after stressing device using a set of ten pulses under dark and (b) UV conditions. In dark condition, device's OFF-state leakage increases and threshold voltage changes, which is absent in the presence of UV exposure.

As discussed above, device degrades with each pulse due to slow detrapping of the carrier. To confirm this, the following measurements are performed. A HEMT device is stressed under the dark condition with a set of ten consecutive pulses of 100-ns each, of the same amplitude applied at drain, while keeping gate biased at 1.5 V. Then, the pulse amplitude is increased to higher voltage level in subsequent set. I_{dc} is measured after each pulse. Here, for a fixed stress amplitude, the degradation in I_{dc} is noted with an increase in a number of stress pulses as shown in Fig. 4(b). For example, when ten pulses of 90 V are applied, I_{dc} degrades with each pulse as depicted in Fig. 4(b). The same trend continues further at higher pulse voltages. At 140 V, the device faces immediate failure after application of the first three pulses. This paper reveals that degradation in AlGaN/GaN HEMT is cumulative in nature. Therefore, repetitive stressing can trigger device failure at voltage much below the dc breakdown voltage. The cumulative nature of degradation is attributed to local charge accumulation due to slow detrapping. This argument is supported by missing degradation after each pulse under UV exposure, as depicted in Fig. 4(b). Here, UV exposure assists in carrier detrapping and the device experiences abrupt failure at 170 V without accumulative prebreakdown degradation.

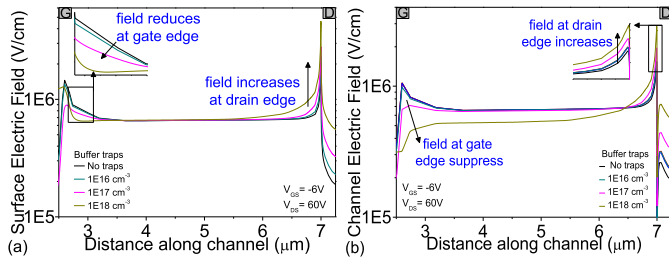
Fig. 6. Simulated electric field profile along the HEMT (a) surface and (b) channel, extracted between gate and drain regions for different buffer trap concentrations.

charge, crowding of equipotential lines intensify under drain contact [Fig. 7(a)], which enhances e-field near drain (Fig. 6). On the other hand, exposure to UV assists in carrier detrapping and reduces the ionized acceptor trap density and its associated negative charge, in the gate–drain region. This allows the potential to spread in gate–drain region [Fig. 7(b)], which relaxes field crowding at drain end and, consequently, improves breakdown voltage of the device under UV exposure.

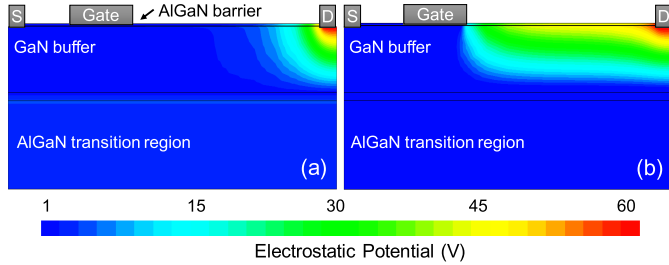
Fig. 7. Electrostatic potential distribution in gate–drain region simulated for (a) high buffer trap density (10^{18} cm^{-3}) and (b) low buffer trap density (10^{15} cm^{-3}) in GaN buffer, extracted at $V_{DS} = 60 \text{ V}$ and $V_{GS} = -6 \text{ V}$.

Fig. 7 shows the simulated electrostatic potential, extracted at $V_{DS} = 60\text{ V}$ and $V_{GS} = -6\text{ V}$, for (a) high buffer trap concentration (10^{18} cm^{-3}), which is equivalent to condition under dark and (a) low buffer trap concentration (10^{15} cm^{-3}), which is the plausible case under UV exposure since exposure to UV light will detraps the carrier and the trap state will turn neutral. Under dark condition, the field localizes near drain contact, which was found to spread across the entire gate-drain access region in the other case. This is explained as follows: acceptor states when occupied carry a negative charge. During device operation under dark, maximum carrier trapping takes place in the gate-drain region, in the presence of high lateral field. This leads to negative charge accumulation in gate-drain region. In the presence of high density of negative

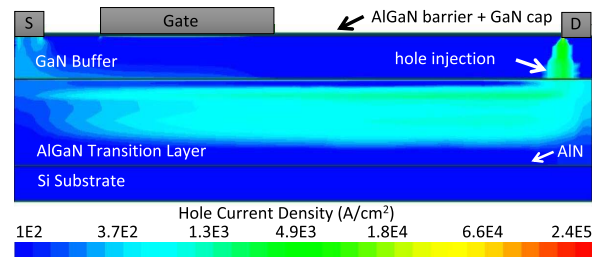
Fig. 8. TCAD contour depicting hole distribution in the device at OFF-state breakdown. Excess holes generated near drain inject into buffer and form parasitic S/D short path in buffer.

electric field. Eventually, it triggers avalanche [20] forming a highly conducting narrow parasitic hole path or filament as shown in Fig. 8. To experimentally verify the explanation, two Ohmic contacts (marked A, B) are realized on either side of a HEMT device, as shown in Fig. 9(b). Contact-A and B are isolated by a 200-nm-deep MESA isolation on either side of main HEMT so that only buffer current flows through them. While stressing the main HEMT, the buffer current between contact-A and B is monitored over the time. The buffer current abruptly increases by 600 times on the verge of failure, as shown in Fig. 9(c) which marks the formation of filament (Fig. 8) and causes permanent device failure. Postfailure analysis, which is discussed in the next section, corroborates well with the TCAD-based findings.

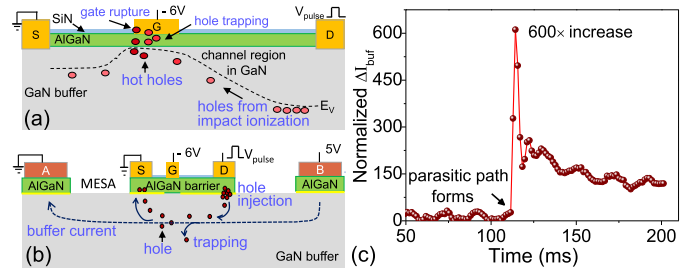
Fig. 9. (a) Device schematic presenting the device failure mechanism under dark condition. Here, GaN cap is not shown for simplicity. (b) Test structure with HEMT device and Ohmic probe contacts (A, B), used to monitor variation in buffer current during OFF-state stress. (c) Change in buffer current measured using test structure in (b) during the OFF-state stress.

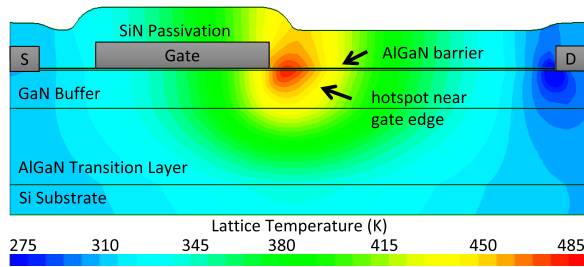
Fig. 10. TCAD contour depicting temperature distribution across the device at device breakdown. Hotspot can be seen near drain side gate edge.

at gate edge toward drain. At high drain voltage, enhanced current density (J) and peak electric field (E) at gate edge forms a hotspot ($J \cdot E$) as depicted from temperature distribution shown across the device in Fig. 10, extracted at breakdown. Failure analysis presented in the later sections for a device which failed under UV, reveals damage at the gate edge, which corroborates well with the failure physics investigated using TCAD simulations.

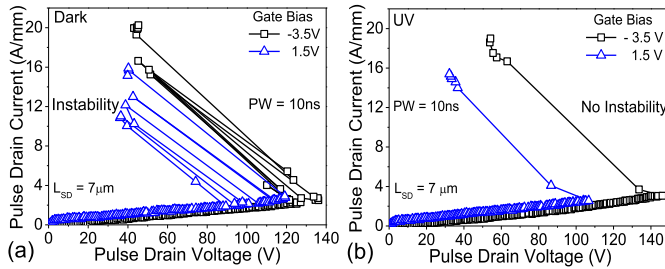
Fig. 11. (a) Snapback instability observed in I - V characteristics extracted under dark conditions using 10-ns-wide PW. (b) Snapback instability absent in the presence of UV exposure.

When devices are stressed using shorter pulses ($PW = 10$ ns), an unstable snapback region is observed in the I - V characteristics beyond the breakdown point, under dark condition. That is, each time the device enters the snapback mode, which is a state before filamentary failure, it recovers back repeatedly, as depicted in Fig. 11(a). However, when the same test is repeated under UV light, the instability vanishes and the device sees clear failure, at higher voltage, as shown in Fig. 11(b). This hints that the observed instability is related to carrier trapping, which is explained as follows: across the wafer and, hence, along the device width, there is always a finite variation in defect density and spatial stress distribution, originating from the MOCVD growth of GaN/AlGaIn. Due to this, trap generation and carrier trapping occur nonuniformly across the device width. This leads to the formation of localized regions, where carrier trapping is higher compared to the rest of the device's active region. Such regions with high trap density, in turn, experience an early shift in electric field peak toward drain, as shown in Fig. 6. This results in the formation of the localized parasitic path(s) as shown in Fig. 8. These localized parasitic paths

The devices, which fail while stressing them using shorter pulses under dark condition, show instability in snapback region at the breakdown point, which was depicted earlier in Fig. 11(a). Postfailure analysis of a device stressed using 10-ns-wide pulse under dark condition shows multiple damage points (cracks) along the device width as shown in Fig. 12(a). Individual crack/defect center independently pushes the device into the snapback state, however, as the carrier trapping and self-heating at shorter pulse are not sufficient for a hard failure

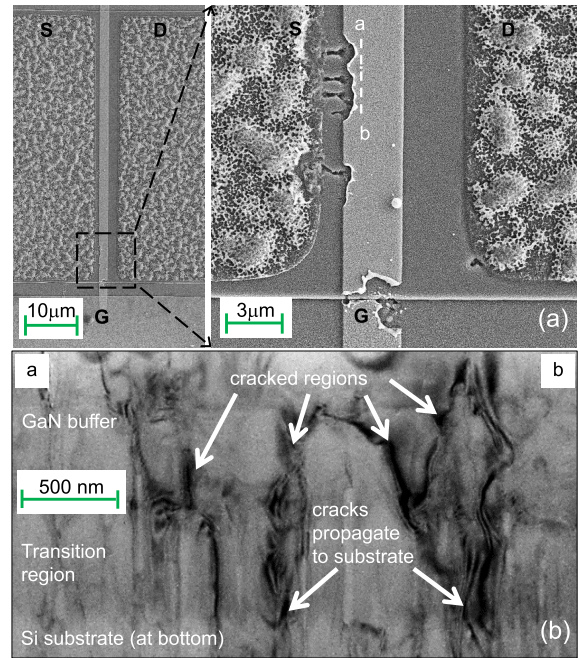
Fig. 12. (a) Postfailure SEM image of a device which failed under dark condition, when stressed using 10-ns wide pulses under OFF-state. It shows multiple damage sites in S-G region. (b) TEM cross-sectional taken along line "a-b" depicts cracks running deep into the buffer and transition regions.

Fig. 12(a) show the SEM image of a device which failed under dark condition in OFF-state. It reveals failure spots in the gate-source region. This is attributed to the accumulation of excess holes under the gate, which are generated from the enhanced Π at drain due to trap-induced peak electric field shift as shown in Fig. 6. TEM cross section taken along the

damaged location in Fig. 12(a) unveils that the cracked source-gate region runs deep into the buffer and reaches the transition region as clear from Fig. 12(b). This possibly results from the thermal stress generated due to the heavy current flow via localized parasitic conductive paths formed in buffer/transition region at breakdown, as learned from the TCAD study (Fig. 8) earlier. This observation corroborates well with the avalanche injection and filamentation theory presented in the previous section. Device failure under dark condition, stressed under ON-state condition, reveals gate-source failure with gate metal getting melted as shown in Fig. 13(a). The holes that are collected under the gate leak through the Schottky junction and increases the gate-source leakage [6]. Moreover, interface defects at Schottky gate increase under this stress [13]. Therefore, gate wears out/melts at the source side as clear from SEM image in Fig. 13(a). EDX analysis at damage location shows 9% Au which melted from gate region, as confirmed from SEM micrograph. Cross-sectional TEM of the dotted area from damaged source-gate region reveals Gallium out diffusion from GaN cap into Ni/Au Schottky gate. This is possibly due to the localized heating associated with high gate-source leakage.

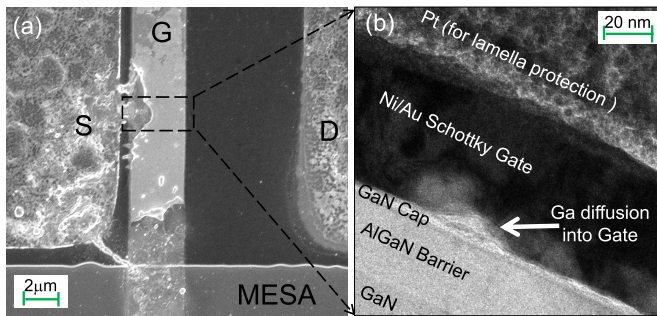
Fig. 13. (a) SEM image of HEMT with $11 \mu\text{m}$ L_{SD} , which failed under dark condition when stressed with 10-ns-wide pulses under ON-state. (b) Cross-sectional TEM taken in the dotted area of the damaged S-G region reveals Gallium out diffusion from GaN cap into Ni/Au Schottky gate.

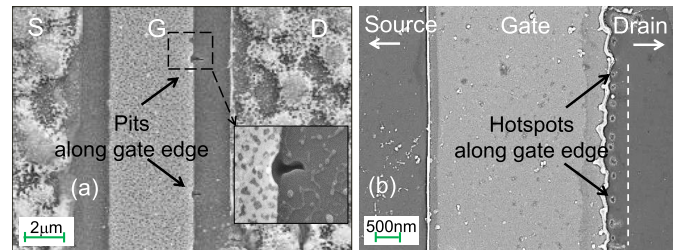
Postfailure SEM micrograph of devices which failed under UV condition in OFF-state is shown in Fig. 14(a). As clearly shown, pits originate at multiple locations along the gate edge toward drain. In devices as presented above, in the absence of traps, i.e., in the presence of UV light, the peak electric field lies at gate edge toward drain. The enhanced normal component of the peak field introduces mechanical strain at gate edge due to inverse piezoelectric field [21]. When the stored elastic energy hits a critical value, the mechanical stress relaxes by the formation of crystallographic defects/pits. Fig. 14(b) shows the SEM image of the device which failed while stressing device using 100-ns-wide pulse under UV exposure in ON-state condition. It reveals the signature of hotspots formed along the gate edge toward drain. As predicted from the TCAD study, in a device without traps, the electric field peak lies at drain side gate edge as shown in Fig. 6. This leads to the formation of hotspot at the gate edge toward drain as shown in Fig. 10, which can be distributed along the

Fig. 14. (a) SEM image of HEMT which failed at 100 ns under UV light in OFF-state condition. Pits get formed at multiple locations along the gate edge toward drain. (b) SEM image of HEMT with $7 \mu\text{m}$ L_{SD} which failed at 100 ns under UV condition in ON-state. Images reveals continuously distributed hotspots along the gate edge toward drain. Gate metal folds up at hotspot locations. No damage is observed at source side.

device width as clear from Fig. 14(b). This leads to electro-thermal instability and failure in the device. At lower PW, when the device is stressed for a shorter duration, the self-heating across the device naturally gets suppressed. As a result, the device sustains higher electric field and needs higher power to fail. Fig. 15(a) shows the SEM image of HEMT failed in ON-state under UV condition, stressed using 10-ns-wide pulses. It shows cracking in gate-drain region. The peak field and hotspot present at gate edge, generate stress in the vicinity of gate and leads to cracking of top AlGaIn/GaN layers. Under the influence of gate-drain electric field, the crack propagates toward the drain as clear from cross-sectional SEM image of source/drain region shown in Fig. 15(b). Moreover, the hotspot under the gate peels-off gate metal as well.

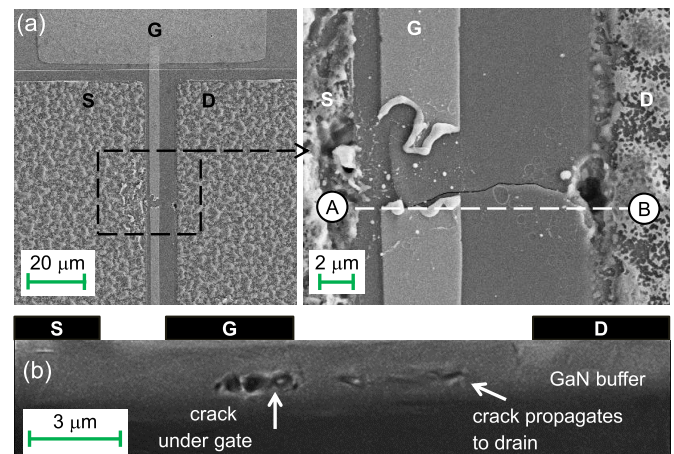
Fig. 15. (a) SEM image of HEMT failed under UV condition, stressed using 10-ns wide pulses depicting damage in G-D region. (b) Cross-sectional SEM image taken along line “A-B” depicts cracks underneath the drain side of gate edge which propagated toward the drain.
