On the Trap Assisted Stress Induced Safe Operating Area Limits of AlGaN/GaN HEMTs

***Abstract*—This experimental study reports a systematic investigation of Safe Operating Area limits in AlGaN/GaN HEMT using sub-µs pulse characterization with on the fly Raman and CV characterization to probe defect and stress evolution across the device. Influence of a recess depth on SOA boundary is analyzed. Post failure analysis corroborates well with the failure physics unveiled in this work.**

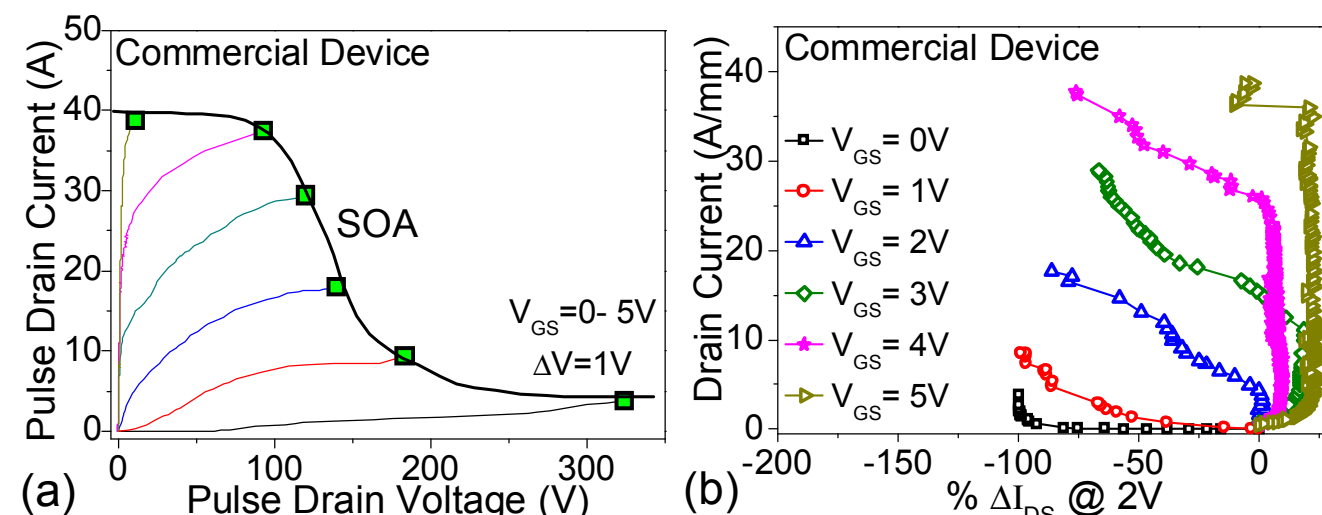
Initially, a commercial p-GaN gate E-mode HEMT was characterized to determine its SOA boundary. Figure 2(a) shows the pulse I-V characteristics with SOA. The associated degradation in spot measured drain current, under high field and high current stress conditions is depicted in Fig. 2(b). As seen, the device degraded to different extent at different gate bias, with maximum degradation in OFF-state. These results depict the importance of this study and highlight the universal nature of degradation trends presented in this work. Next, pulse I-V characterization of fabricated device was done under dark and with UV exposure, to independently determine impact of traps and self-heating on the SOA boundary as shown in Fig. 3(a). Significant improvement in SOA was observed with UV exposure, which signifies the hidden role of surface and/or buffer traps on SOA reliability. A comparison of drain current degradation trends captured in dark and UV condition, is presented in Fig. 3(b). It reveals, negligible degradation in presence of UV whereas the drain current faced significant degradation in dark. And the same observation persists at different gate bias. Possibly, UV exposure de-traps the carries trapped at different locations in the device, and mitigates the device degradation.

Figure 2. (a) Pulse IV characteristics of a commercial GaN device with SOA boundary marked. (b) Percentage change in linear drain current measured after each voltage pulse, at 2V dc. Severe degradation is observed at different gate bias with highest degradation (~100 %) under OFF-state.

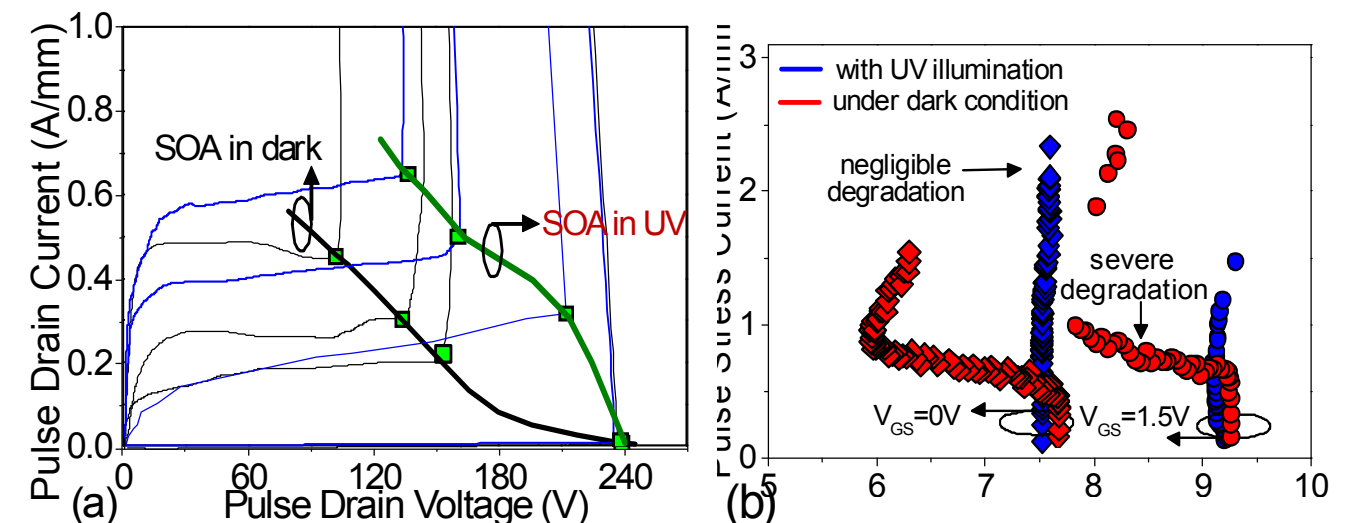
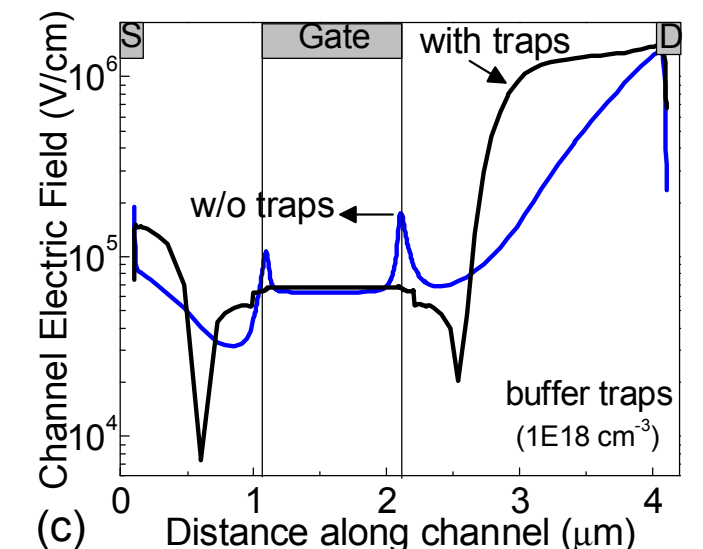
To understand, the physics of SOA improvement with UV, in further detail, a HEMT structure was simulated in TCAD at different buffer trap concentrations. And the electric field distribution in channel was extracted in each case as shown in Fig. 3(c). It revealed that the peak electric field in the channel shifts from gate to drain edge in presence of buffer traps, which is equivalent to the case of I-V measurements done under dark. In absence of traps the electric field peaks at the gate edge which occurs when the UV exposure was present while stressing the device. Therefore, traps can modify the field distribution and hereby potentially govern the device degradation via field driven mechanisms like inverse piezoelectric effect and influence the SOA boundary of AlGaN/GaN HEMTs. Here, effect of surface states is not studied, as the devices used in this study were passivated.

Figure 3. (a) Safe Operating Area of AlGaN/GaN HEMT under dark and UV condition. Figure highlights the trapping limits SOA boundary. (b) Comparison of degradation in linear drain current measured after each stress pulse, under dark and UV conditions. UV illumination effectively suppresses degradation by assisting in the carrier de-trapping. (c) Simulated electric field profile in channel, with and w/o buffer traps shows peak electric field shifts from gate to drain edge in presence of traps, which is the case of test done in dark.

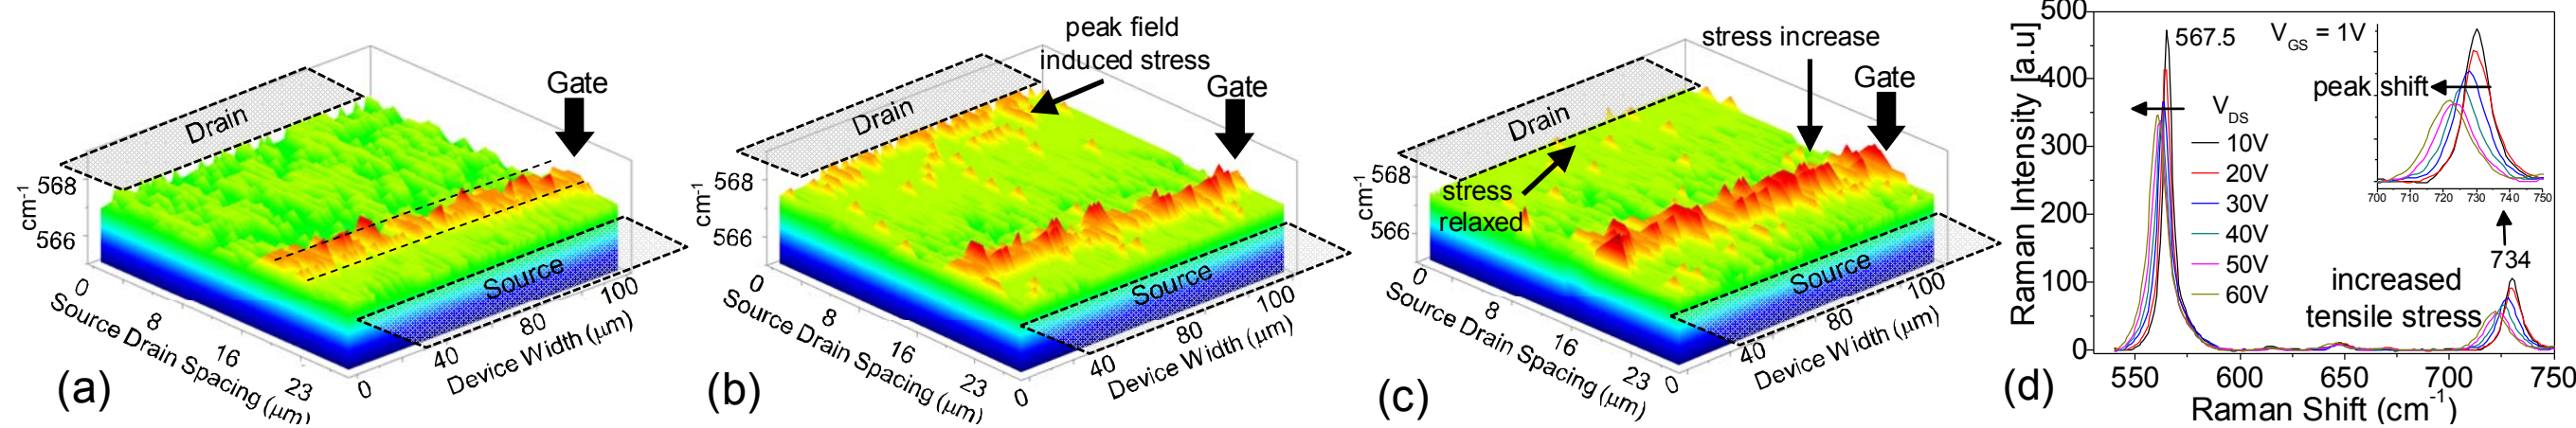
Now, as it is clear that traps can modify the field distribution in GaN HEMT, one would be curious to study its impact, if any, on the mechanical stress introduced in the device via inverse piezoelectric effect. A device was stressed under dark and UV conditions. 2D map of the stress distribution in source to drain region was recorded using on the fly Raman spectroscopy at regular intervals during the stress. Figure 4(a) shows the Raman map recorded in the pristine device, before stress that is under zero bias condition. It unveils the presence of high compressive stress under the gate finger. Then the device is stressed in OFF-state, under dark condition and the corresponding stress map is shown in Fig. 4(b). It reveals that compressive stress builds up at the drain edge and in drift region, under the dark condition. On the other hand, with UV illumination compressive stress was missing in the drain and drift region, and it was present only under the gate as depicted in Fig. 4(c). This result corroborates well with observation of trap induced field shift in GaN HEMT. Compressive stress develops at the drain edge due to excessive trapping, which shifts the peak electric field from gate to drain edge. UV exposure de-trapped the carriers and restored the peak stress to the gate finger. When the device is stressed under ON state, Raman peaks for GaN; $E_{2\text{-}H}$ (567.5 cm^{-1}) and $A_{0\text{-}L}$ (735 cm^{-1}), shift towards left with increasing stress at the drain as depicted in Fig. 4(d). This unveils that the tensile stress at the gate edge towards drain, increases with drain voltage. The increased mechanical stress creates defects/cracks in gate/drift region when its elastic energy hits a critical value [17]. DC I-V and C-V measurement were done at regular intervals during the test. Trap density was extracted in gate, gate-source and gate-drain regions at different stress levels. Figure 5(a) shows the variation in trap density in various regions of the device. A significant increase in trap density is noticed in the gate-drain region [9] with increasing drain stress. Here gate-to-drain trap density increases at a much higher rate than in the gate-to-source region. This is attributed to the piezoelectric stress developed in gate-drain region which generates new defects as discussed above. Moreover, a positive V_{TH} shift is observed with stress, as depicted in Fig. 5(b) and it points to accumulation of negative charge underneath gate via electron trapping. Also, the increased device R_{ON} and degraded drain current, point to electron trapping in gate-drain region.

Figure 4. (a) Raman map captured in source-drain region of pristine device, before stress. Figure reveals compressive stress under gate finger possibly due to gate recess. On the fly Raman map was captured during OFF-state stress (V_{DS} 60V@ V_{GS} -6V) (b) in dark and (c) with UV illumination on device. Figure (b) shows stress accumulates at drain edge when device is tested under dark condition, while stress builds up at gate edge with UV exposure as shown in (c). In dark, trapping in buffer and barrier region, causes peak electric field to shift to drain edge as seen in simulation result (Fig. 3c). UV exposure, suppressed trapping by de-trapping carriers and restored the peak field back to gate edge as evident from increased stress at gate under UV in Fig.(c). Fig.(d) shows Raman spectra spot measured, under ON-state, at gate edge towards drain at different drain stress. Left shifting in E_2(H) (567.5 cm^{-1}) and A_1(LO) (730cm^{-1}) Raman peaks of GaN reveal increased tensile stress at gate edge with increase in drain voltage.

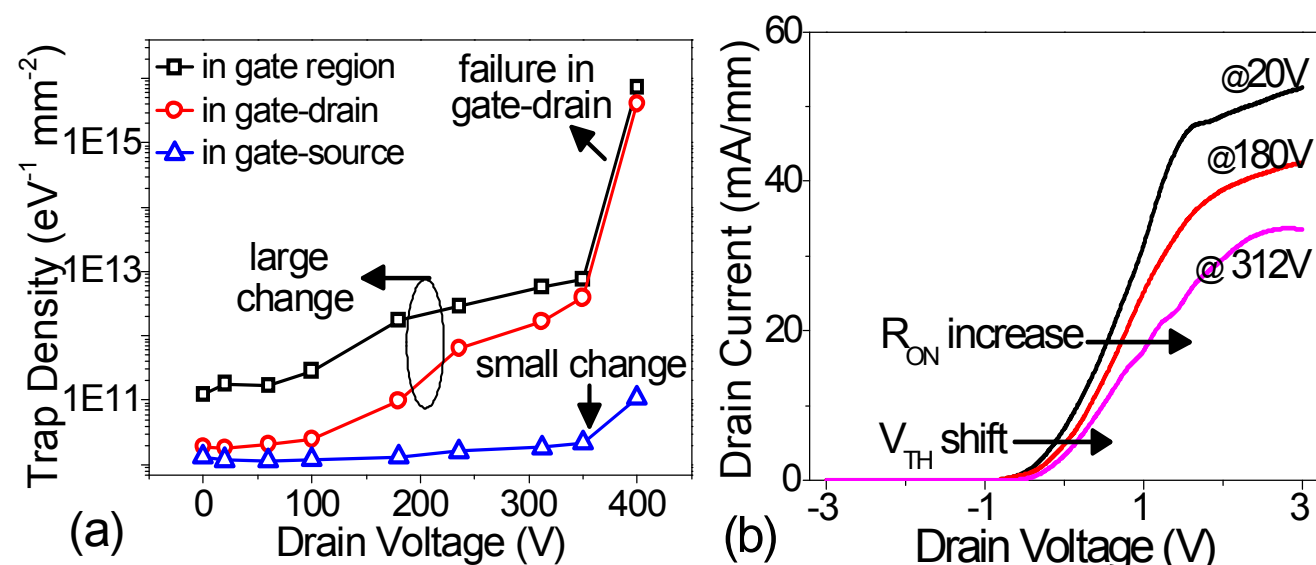
Figure 5. (a) Increase in trap density captured after each stress voltage pulse. Rapid increase in trap density in gate-drain region can be seen. (b) Transfer characteristics of HEMT recorded at regular intervals during the test shows shift in threshold voltage and increase in R_{ON} with increase in drain stress.

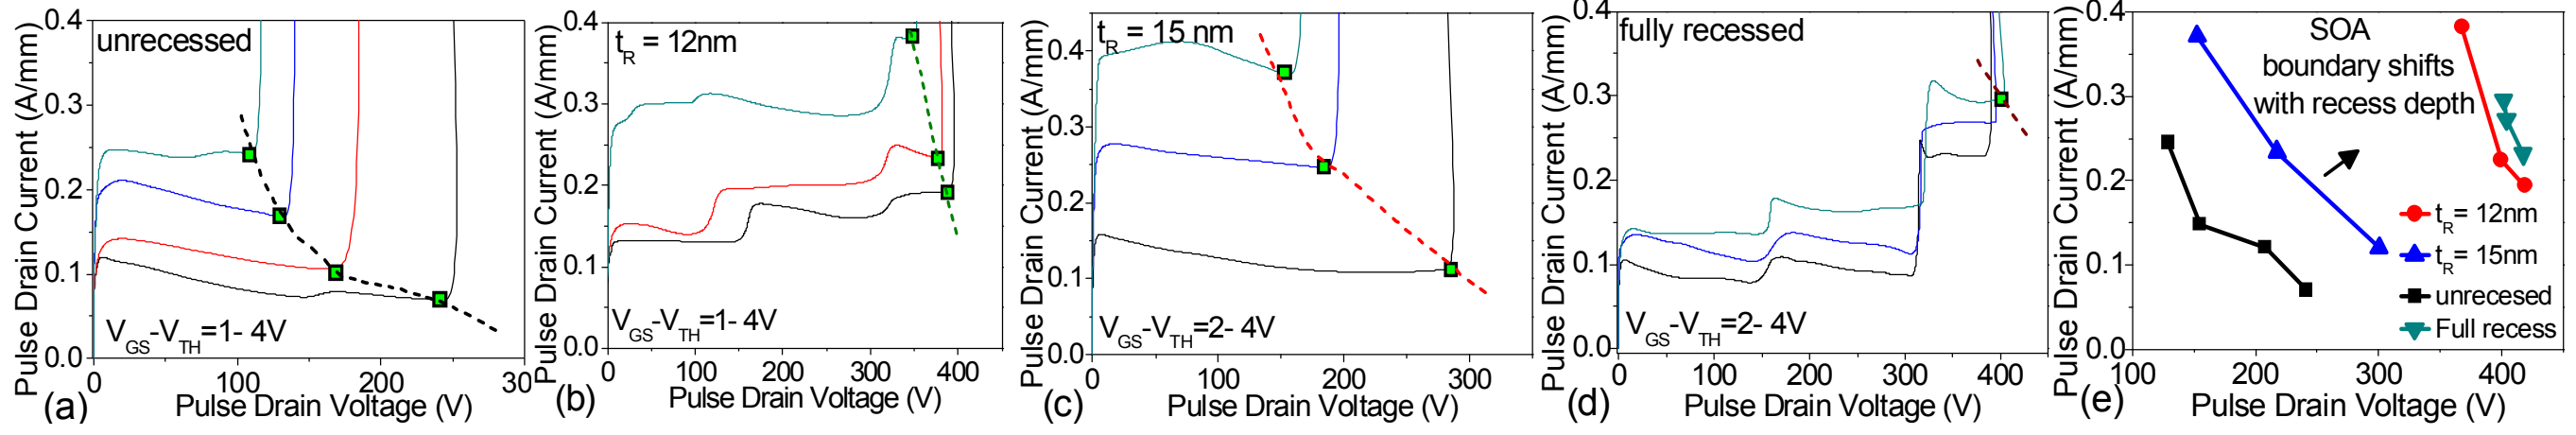
Devices with different recess depth were characterized to determine their SOA boundary as shown in Fig. 6(a)-(d). Device without gate recess exhibited a narrower SOA as depicted in Fig. 6(a), while in devices with full recessed gate, the failure occurred at a fixed drain voltage independent of applied gate bias as seen in Fig. 6(d). This reveals field limited SOA in fully recessed structure and points to a possibility of field modulation with recess depth, as discussed later. A comparative analysis of SOA boundaries of devices with different recess depth is done as in Fig. 6(e). It reveals that SOA boundary shifts with recess depth and it can be maximized using an optimum recess depth or with a partial recessed gate. To further understand it, the linear drain current was spot measured in each case. Figure 7(a) presents a comparison of distinct degradation trends in drain current as function of gate recess depth. It unveils that the percentage degradation in the device reduces with increase in recess depth. Devices without recess undergo up-to 30% degradation in drain current, while devices with 15 nm recess depth degrades only up-to 10%. On the other hand, fully recessed devices suffered from maximum degradation of 90%. To understand the underlying physics, TCAD simulation of a device was done for different gate recess depth and variation in electric field distribution in channel, is determined for different recess depths as depicted in Fig. 7(b). It shows that in case of non-recessed or fully recessed structure, the electric field peaks at either the gate or drain edge. However, for intermediate optimum recess depth, the field redistributes such that peak field gets suppressed both on gate and drain edges.

Figure 6: SOA boundary of devices with different recess depth (t_R). (a) Figures shows narrow SOA boundary in HEMT without (b)-(d) shows SOA of devices with increasing recess depth. Figure reveals that with gate recess the SOA broadens however, with fully recessed gate as in (d) device failure occurred at a fixed drain voltage independent of gate bias and reveals field limited SOA in recessed structure. (e) Shift in SOA boundary with recess depth is observed, with optimum SOA achieved with 15nm recess depth.

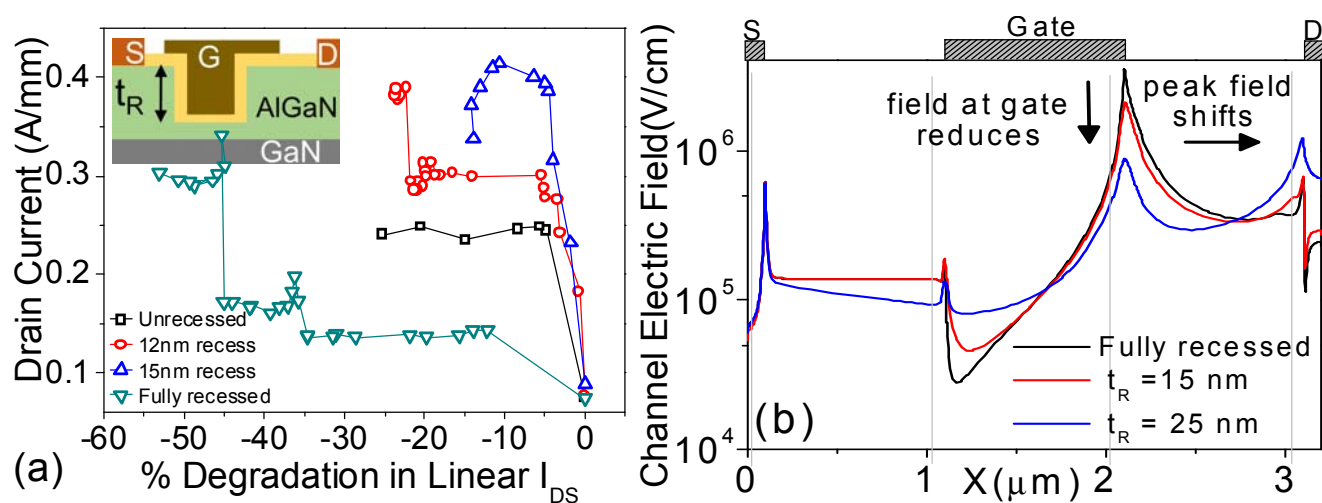
Field suppression at drain reduces impact ionization rate and avoids early avalanche in device. Low field at gate, slows the hotspot formation and hot electron induced degradation. Therefore, redistribution of channel field with suppressed peaks at optimum recess depth, improves device reliability and broadens the SOA. This explains the as observed dependence of SOA on recess depth. in this work.

Figure 7. (a) Inset shows schematic of HEMT with recessed gate where recess depth (t_R) is varied. Percentage degradation in linear drain current for devices of different recess depth, drain stressed under ON-state (V_G-V_{TH}=2V). Maximum degradation occurs in device with full recess and least occurs in device with 15nm recess depth. (b) TCAD simulation for different recess depth shows electric field peaks at gate edge in unrecessed structure. With increase in recess depth, peak field shifts to drain edge for 25nm recess depth. 15nm partial recess, suppresses peak at both gate and drain edge and improves SOA

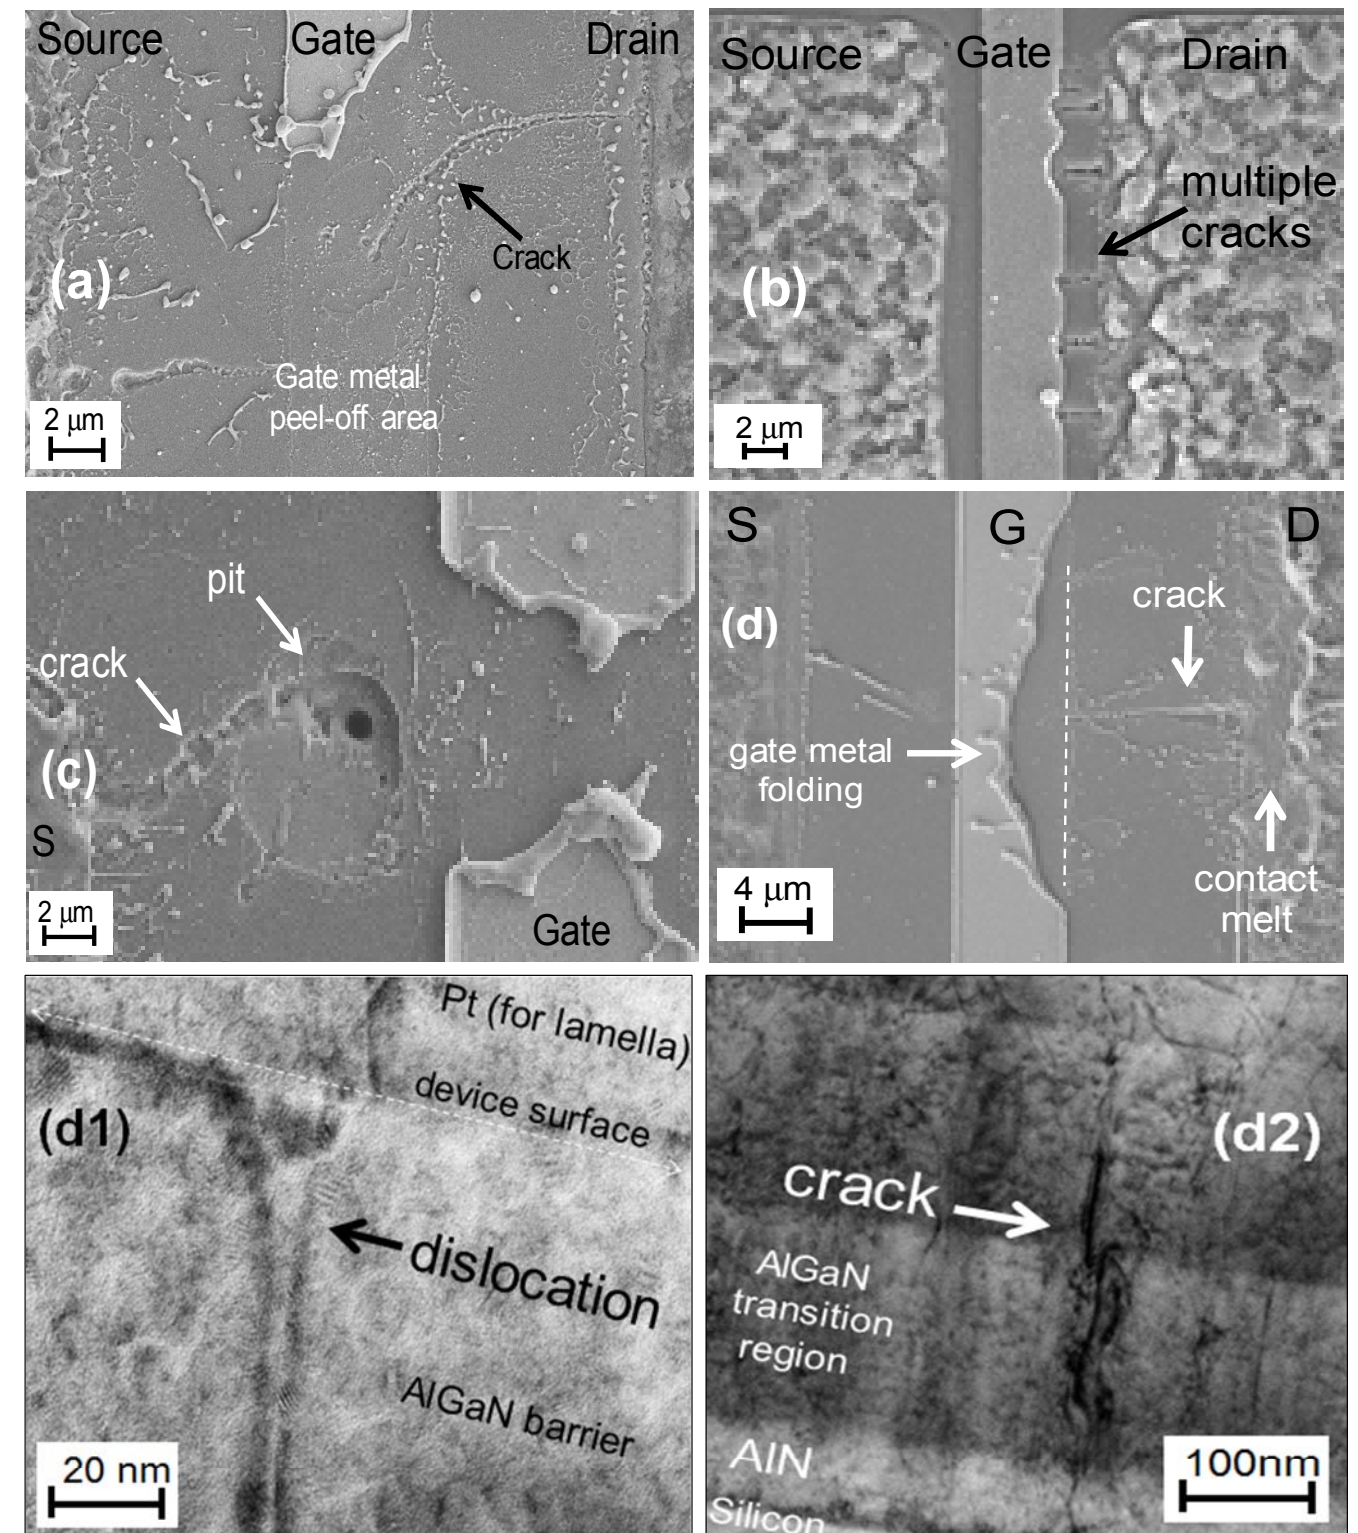
After pulse characterization, the damaged regions of failed devices were analyzed using Scanning Electron Microscopy (SEM), Energy Dispersive X-Ray Spectroscopy (EDX) and Transmission Electron Microscopy (TEM) to gain physical insight into the underlying degradation mechanism. Figure 8(a) shows the post failure SEM micrograph of a device which failed in OFF-state under UV condition. It depicts a part of gate metal finger blown-off at failure without any trace of material melting. This highlights the possibility of purely field driven failure. Presence of cracks underneath gate, towards drain side, reveal that the damage occurred due to high mechanical stress at gate edge. This observation nicely corroborates with the Raman stress map shown in Fig. 4(c) where the region under gate finger was found to be always under a compressive stress. The inverse piezoelectric effect introduces mechanical strain at gate because the channel electric field peak peaks at the gate edge in absence of carrier trapping as revealed by TCAD results in Fig 3(c). SEM image of a device which failed at a stress of 10 ns pulse duration is shown in Fig. 8(b). It unveils multiple damages formed along the gate edge in the gate-drain region. MOCVD grown AlGaN/GaN stack, possess a finite defect density which can introduce non-uniformity in carrier trapping and associated peak field shift, at drain, along the device width. Enhanced impact ionization and carrier injection into the buffer, in these localized high field regions invokes avalanche instability and causes multiple damages [9] as seen in Fig. 8(b). Figure 8(c) shows post failure SEM image of a device which faced premature breakdown under ON-condition. It reveals, presence of a pit triggered device failure in gate-source region. Pits and dislocations are native to AlGaN/GaN material system and originate from lattice mismatch between different layers. Post failure SEM image of device which was

failed under OFF-state is shown in Fig. 8(d). It shows failure occurred with a crack in gate-drain region and gate metal folding exclusively at the drain side gate edge. Metal melting/folding reveals the thermal nature of the failure. TEM cross-section was taken along the gate edge (white dotted line in Fig. 8d). It unveils the presence of a dislocation at the gate edge, as shown in Fig. 8(d1), which caused failure. The cross-sectional image in Fig. 8(d2) also reveals that the damage occurred deep in the buffer with the newly formed crack reaching till the Si substrate. This can be explained as follows; dislocations provide parasitic path for current leakage and material diffusion. This weakens the material strength via electro-chemical reactions [18] and creates local damages.

Figure 8. (a) Post failure SEM image of device failed in On-state. Figure shows cracking underneath gate blew-off the gate finger which was already under compressive stress as clear from Raman plots. (b) Multiple damages observed in gate-drain region reveal failure due to non-uniform trapping and stress distribution along device width as shown in Fig. 4a-c. Defects like pit can trigger failure as shown in (c). On-state failure in (d) occurred with crack in gate-drain region with gate metal folding. TEM cross-section taken along gate edge (white dotted line) shows presence of dislocation at gate edge, as shown in (d1) and crack in buffer reaching till Si substrate as in (d2).
