Time Dependent Early Breakdown of AlGaIn/GaN Epi Stacks and Shift in SOA Boundary of HEMTs Under Fast Cyclic Transient Stress

Bhawani Shankar¹, Ankit Soni¹, Sayak Dutta Gupta¹, Swati Shikha¹, Sandeep Singh¹,
Srinivasan Raghavan² and Mayank Shrivastava¹

¹Department of Electronic Systems Engineering and ²Center for Nanoscience and Engineering,
Indian Institute of Science, Bangalore, India, email: mayank@iisc.ac.in

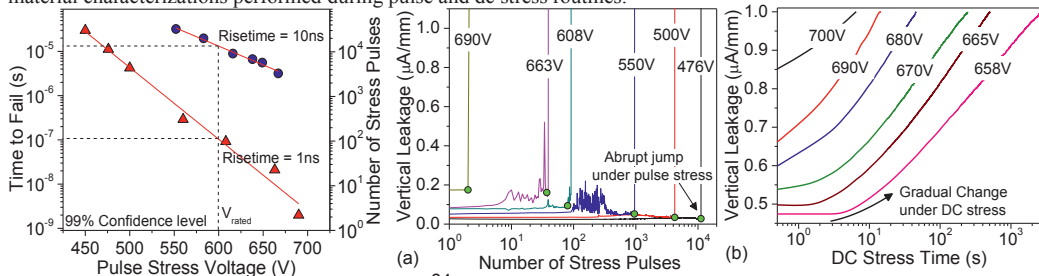
Time to Vertical Breakdown under Pulse Stress: Time to fail (TTF) extracted using fast transient cyclic pulse stress shows exponential dependence on applied stress voltage (Fig. 5) however the TTF was found to be much smaller compared to the same under DC stress case. For instance, 600V GaN Epi-stack qualified for 10-year lifetime under DC stress, failed after ~100 pulses, each being 500ns wide. Interestingly, TTF was found to improve when pulse rise time was increased, which indicates transient time dependent failure to be related to rate of change in electrical stress. Unlike under DC stress case (Fig. 6b), under cyclic pulse stress the vertical leakage with stress time remain unchanged till the verge of failure (Fig. 6a). Rapid and more sever changes in device characteristics are observed under pulse stress compared to that under dc condition (Fig. 7). Drain to substrate vertical leakage hysteresis was found to increase with stress time under pulse stress (Fig. 8), which points to charge trapping in different layers present between drain and substrate. PL mapping of drain-source region (Fig. 9) reveals increased defect generation introducing deep level traps within energy range of $E_C - 0.48$ eV and $E_C - 1.14$ eV. Highest PL intensity is observed near the drain contact (Fig. 9c). CL spectra (Fig. 10) taken at same location verifies increase in Blue (BL) and Yellow luminescence (YL) intensities with stress and penetration depth of ~1.2 μm from top surface. Hence, defects in GaN buffer are located close to 1.2 μm below surface in the drain contact vicinity. Raman map confirms mechanical stress builds up at the drain contact edge after the device is stressed for 5000 cycles under pulse condition (Fig. 11). Since AlGaIn is transparent to used visible (532 nm) laser, the stress signature received is from GaN buffer. This correlates well with penetration depth calculated from CL. Post failure cross-sectional SEM shows a catastrophic damage in GaN buffer, in vicinity of drain contact (Fig. 12). HR-TEM of defected region reveals fine cracks near GaN buffer and AlGaIn transition interface (Fig. 12). However, under DC stress, damage is localized to device surface and no failure signature is observed in the bulk.

$(e_{33} \frac{C_{13}}{C_{33}} - e_{31}) E_z$. Here, σ_{xy} is in-plane strain, e_{33} , e_{31} are piezoelectric coefficients and, C_{13} , C_{33} elastic stiffness tensors. Piezoelectric strain generates defects in bulk region, in drain contact vicinity, where peak field lies and accumulates with increasing number of stress pulses (Fig. 11b). Furthermore, under pulse stress, the piezoelectric AlGaIn/GaN stack undergoes cyclic loading via mechanical strain generation-relaxation as evident from the Raman map, captured before and after pulse stress (Fig. 11). Over time, cyclic stress causes changes in piezoelectric properties [13] and results in time dependent strain variation [15]; $\sigma_{xx}(t) = \sigma_0 (1 - e^{-\frac{t}{\tau}})$. Such an electrical fatigue is accumulative in nature as evident from increased YL, BL bands in CL spectra (Fig. 10) and increased hysteresis (Fig. 8) over time. Electrical fatigue nucleates micro-cracks at GaN buffer/AlGaIn transition interface which has highest residual stress (Fig. 12). High strain energy at crack tip under cyclic electrical loading propagates it towards device top and hits the surface to form pits and causes catastrophic failure (Fig. 12). Fatigue accumulation accelerates with rate of change of electric field (pulse rise time), resulting in drop in TTF for faster cyclic transients (Fig. 5).

Fig. 5. Time to fail (TTF) under pulse stress conditions presented on left y-axis and the corresponding number of pulses required for device failure at different voltages, shown on right side y-axis. Here pulse width of 500ns and OFF state period between two consecutive pulses are 100 μ s. Figure depicts, TTF is significantly lowered under pulse operation compared to that under dc and exhibits dependence on the rise time (slow rate) of the stress pulse.

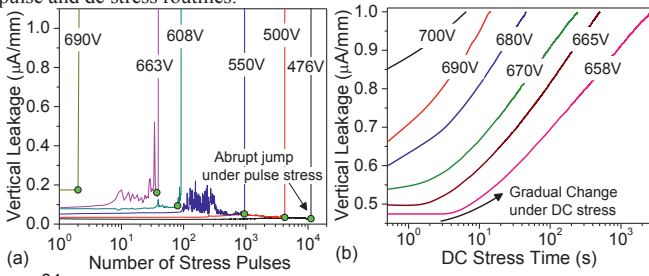
Fig. 6. (a) Time evolution of vertical (drain to substrate) leakage current at different (a) pulse voltages and (b) dc stress voltages. Under pulse condition the leakage remains unchanged until the hard breakdown point where it increases abruptly. On the other hand, it increases gradually under DC stress.

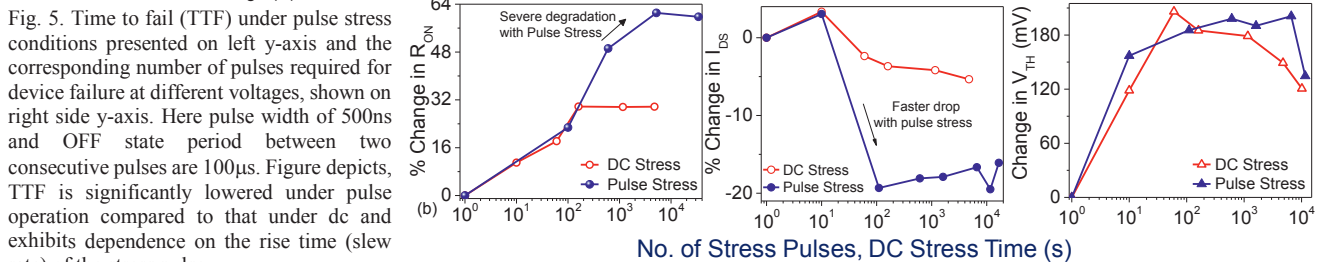
Fig. 7. Degradation in the device parameters recorded on-the-fly during dc and pulse stress measurements done at 185V. (a) ON-resistance (R_{ON}) increases and (b) ON-current (I_{ON}) decreases at a much faster rate under pulse stress condition when compared to DC stress. With stress time, the density of deep levels in GaN increases, as evident from increased Yellow luminescence and Blue luminescence in Fig. 10, which electrostatically influence 2DEG and increase R_{ON} and lowers I_{ON} . Threshold voltage instability gets accelerated under pulse stress. For instance, with just ten stress pulses applied on drain, the V_{TH} changed by 180mV as evident in (c).

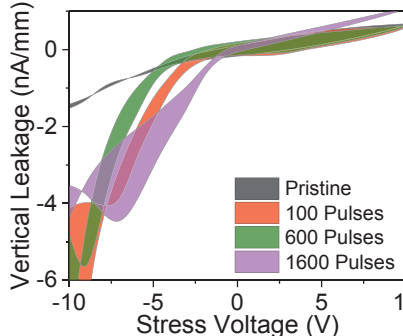
Fig. 8. Hysteresis behavior recorded between drain and substrate current after different number of stress cycles (pulse stress voltage = 200V). Increase in loop area highlights charge /trap accumulation in buffer and transition regions with each stress pulse, attributed to increased density of defect in bulk GaN. This correspond to blue and yellow luminescence as visible from broadened FWHM of defect band (400-600nm) in CL spectra of GaN recorded close to drain edge. Carrier de-trapping is slow from deep levels, which results in accumulation of trapped charges in buffer layers with increasing stress cycles. This translates to increased hysteresis.

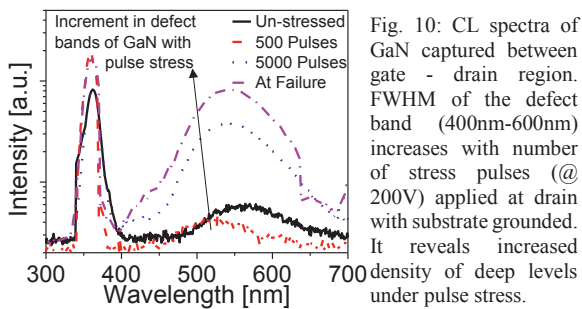
Fig. 10: CL spectra of GaN captured between gate - drain region. FWHM of the defect band (400nm-600nm) increases with number of stress pulses (@ 200V) applied at drain with substrate grounded. It reveals increased density of deep levels under pulse stress.
